Report on NTSF Embankment Failure

Cadia Valley Operations

Independent Technical Review Board

Date: April 17, 2019

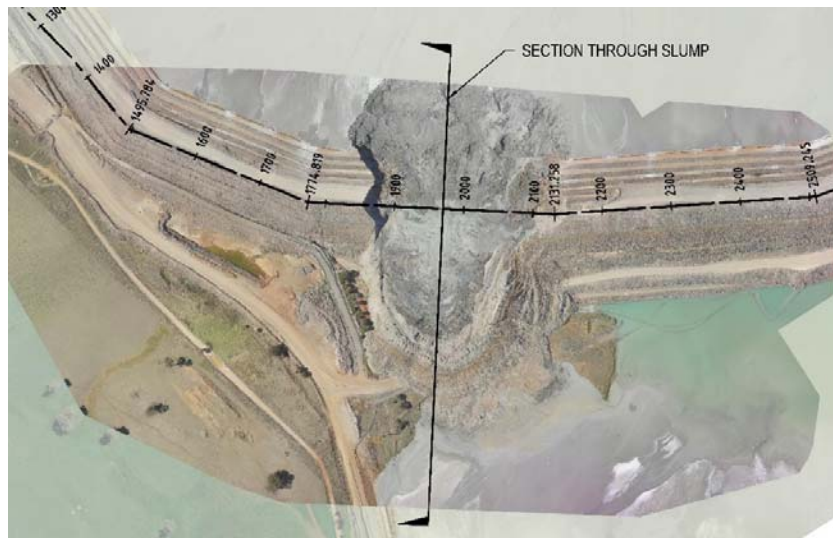
Figure 2-1: NTSF Slump on March 10, 2018, 10:00

A detailed timeline around the failure is presented in Appendix B. In general terms, prominent cracks in the south face of the NTSF were first observed between 08:00 and 09:00 on the morning of March 9, 2018. Senior site personnel inspected the cracks and identified further cracks throughout the day as they developed. Processing plant operations ceased at 15:00. At 16:00, significant ground heave was detected at the toe of the NTSF adjacent to the cracks observed higher up. This prompted an evacuation of the worksite and a small number of downstream residents. Between 18:45 and 19:00, the failure was discovered by site personnel, who had travelled to the NTSF to make displacement observations. An approximately 300 m section of the NTSF wall had failed between chainage 1850 – 2150 with displacement extending southward by about 170 m as shown in plan on Figure 2-1 and in section on Figure 2-2.

Morphologically, the movement may be classified as a SLUMP and, given the extent of its movement, prior to its cessation, it can be described as a MOBILE SLUMP. The kinematics of the slump are more translational than rotational, indicating that foundation conditions constituted a controlling factor in the mechanics of the failure. However, at an early stage of the investigation, it was important to screen all reasonable explanations for the failure.

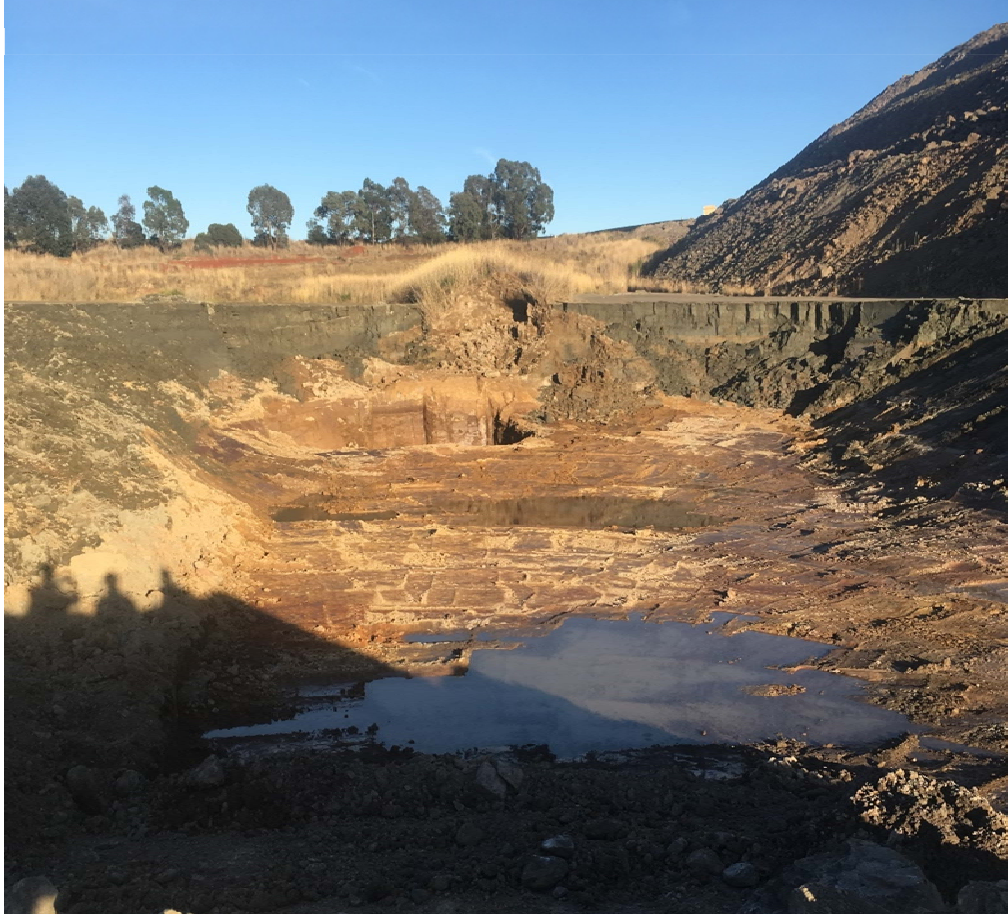
Figure 3-7: Exposed foundation on January 18, 2018

At the time of the Event, the Stage 2 Buttress construction had not commenced in the slump area but had commenced in other sections of the NTSF. Based on information obtained from test pits, the designers, in 2017, had identified the need for stripping at the toe of the NTSF prior to Stage 2 Buttress placement. In one stripping area, where the slump eventually occurred, in excess of 4 m of tailings had accumulated in a depression which required at least partial removal. This excavation (approximately 5.5 m deep), was undertaken in January 2018, exposing weak weathered foundation material. This is illustrated in Figure 3-7. This exposure remained open until the time of the Event.

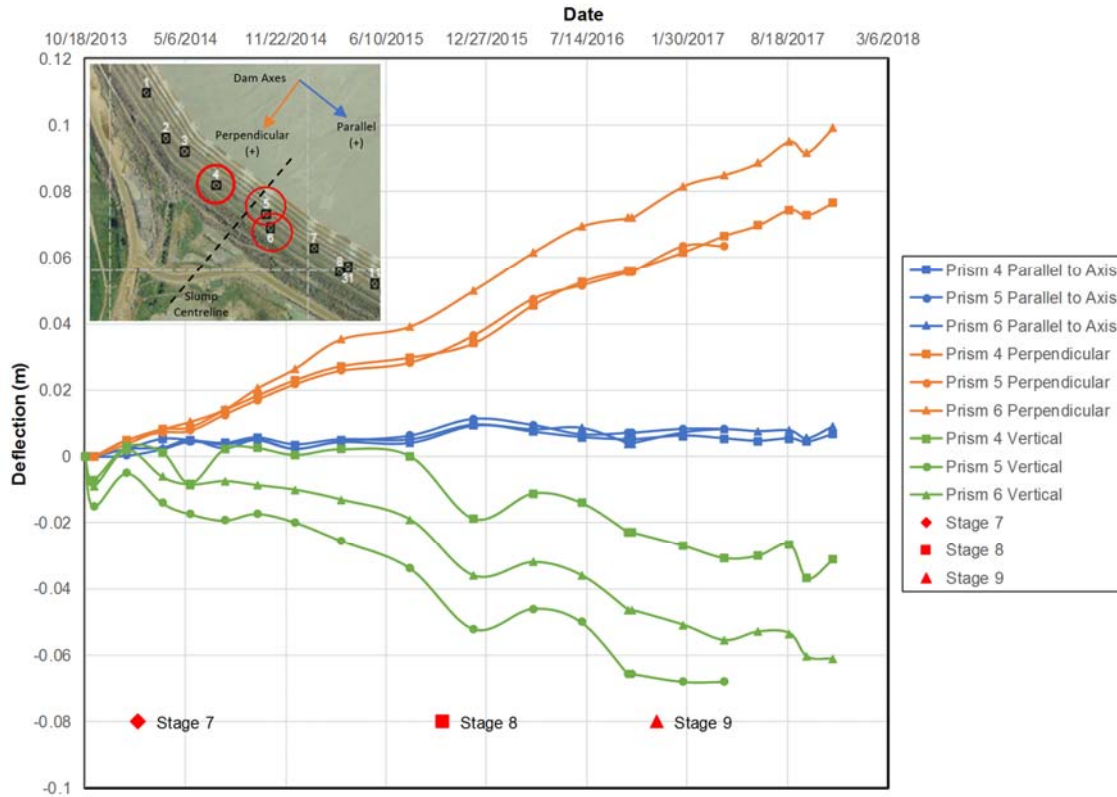
Figure 3-10: Survey prism movement in five years preceding the slump

From October 2013, survey prisms grouted into large boulders on the dam crests were used for monitoring deformations. Prisms were located on the crests of Stages 4, 5 and 7. However, these were not placed in position until the subsequent embankment stage had been constructed. Both vertical and horizontal displacements were recorded. Displacements perpendicular and parallel to the dam axis, together with vertical displacements are shown in Figure 3-10.

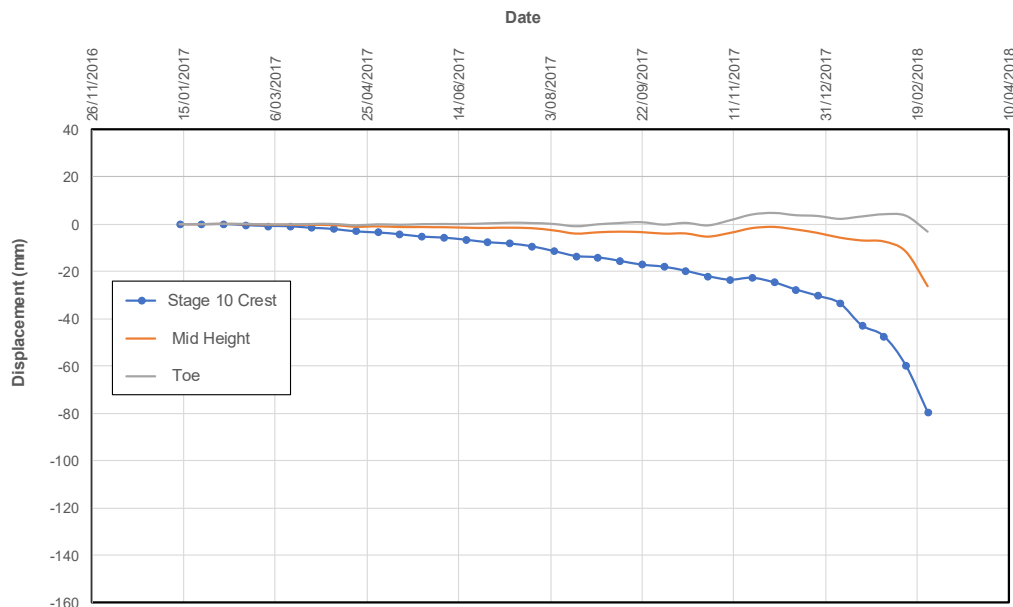
Figure 3-12: InSAR surface movement measurements at Ch 2000

Data at the crest show an increased rate of movement from January 8, 2018. A small rate of movement was observed at mid-height while none was apparent at the toe. Comparing this with terrestrial survey data reveals a similar rate of movement of the NTSF embankment increasing markedly at the beginning of January 2018, see Figure 3-13. It is of interest to note that this corresponds with the construction of the Stage 1 Buttress and excavation at the toe of the NTSF.

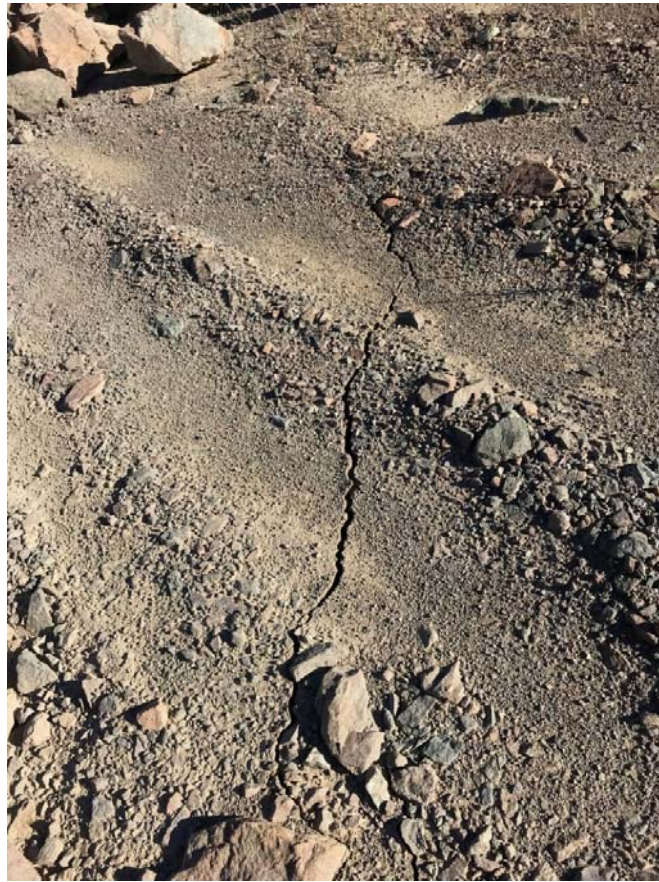
Figure 3-14 shows cracking on the Stage 5 crest at 07:48 on the morning of the Event. Figure 3-15 shows cracking in Stage 8 looking west, and Figure 3-16 taken between 15:50 and 16:30 shows cracking and heaving at the toe of the embankment, indicating that failure was imminent. In line with the CVO Dam Safety Emergency Plan, the decision was made to evacuate the work-site which, given the dynamics of Phase 2 of the Event, most likely prevented substantial injury to site staff. The observation that the vertical cracks on the various stages displayed no vertical offset, but did indicate a significant extension displacement, is also of diagnostic value.

Figure 3-14: Photograph of cracking on the Stage 5 crest beside Standpipe P9 taken at 07:48, March 9, 2018

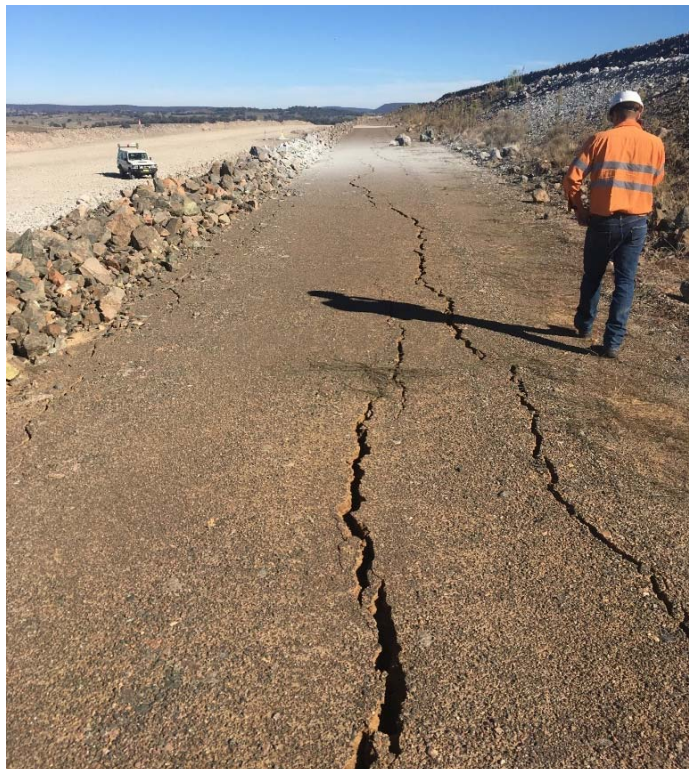
Figure 3-15: Stage 8 crest cracking looking west, March 9, 2018

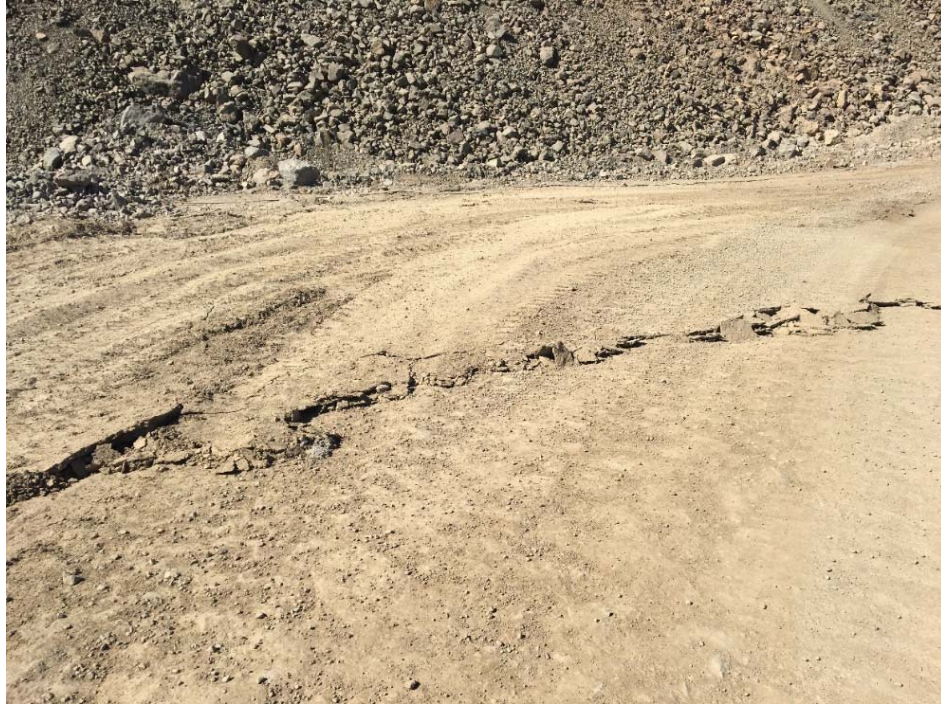
Figure 3-16: Cracking and heaving of haul road at Chainage 2060, March 9, 2018

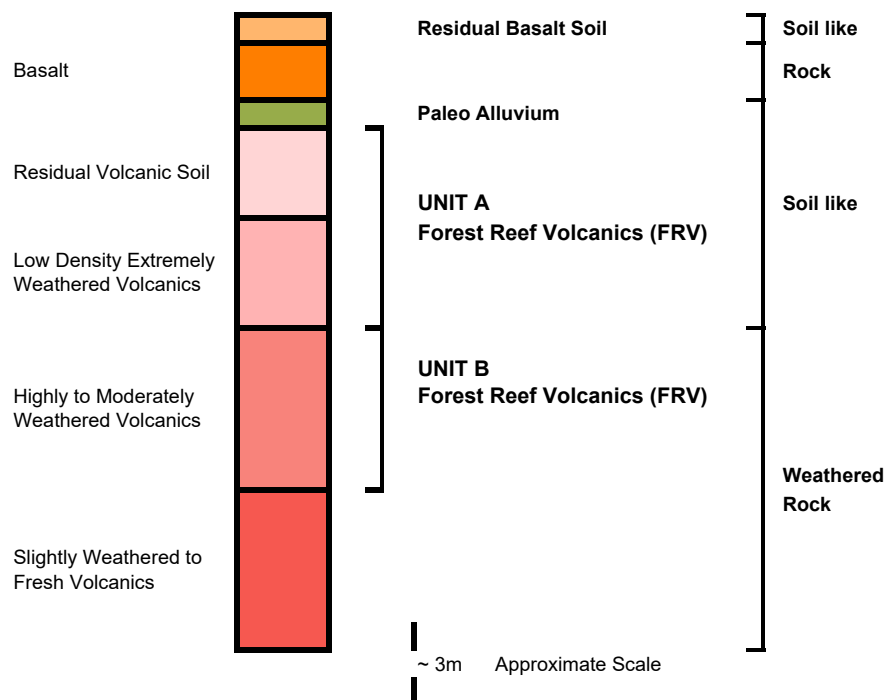
Figure 4-4: Geological units intersected at NTSF slump

The geological model in the vicinity of the NTSF embankment failure is summarised in Figure 4-4.
