Appendix C:

Geology and Field Characterisation

CADIA NTSF FAILURE INDEPENDENT TECHNICAL REVIEW BOARD

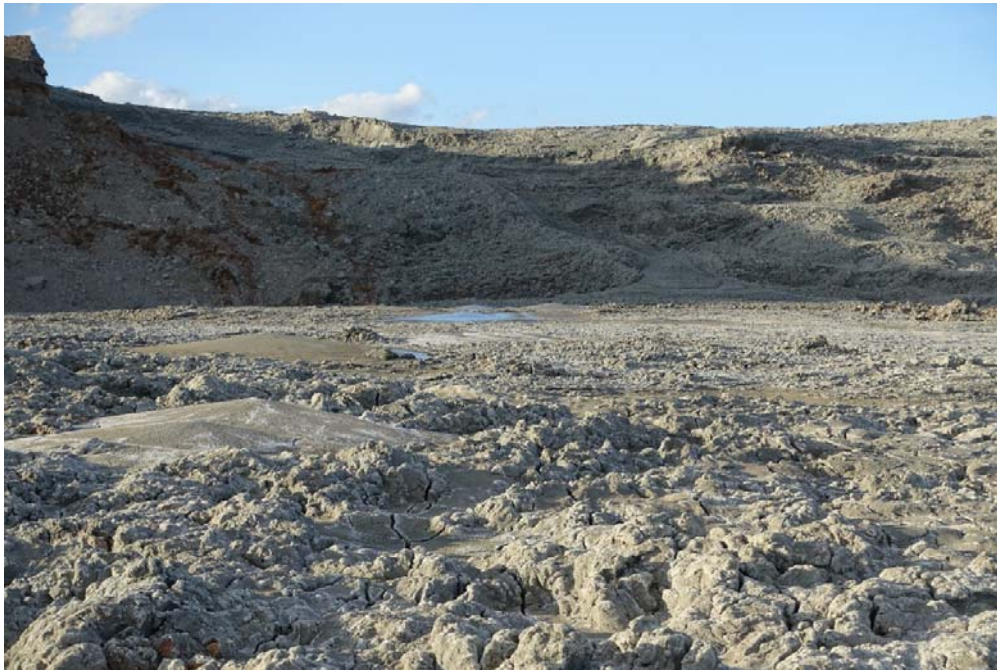
Figure C4-1: Sand boils on slumped surface sampled as HA402

The second sample, HA402, was taken by carefully scraping the surface of a number of randomly selected sand boils using a small hand shovel. Sand boils typical of those sampled can be seen in Figure C4-1. To provide sufficient sample for testing, a number of sand boils were 'scraped', a task that proved difficult as the tailings were still saturated and prone to liquefaction. This sample was taken as it represented the coarsest phase of the tailings and material more prone to liquefaction.

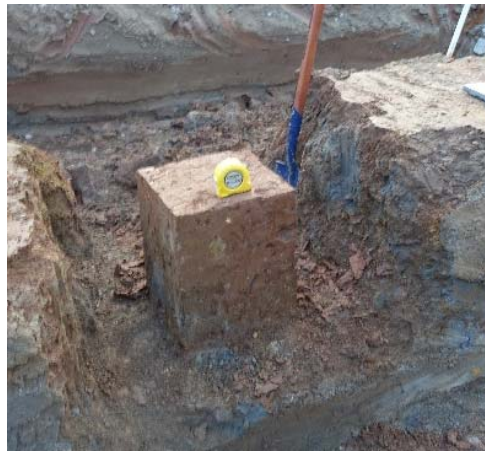
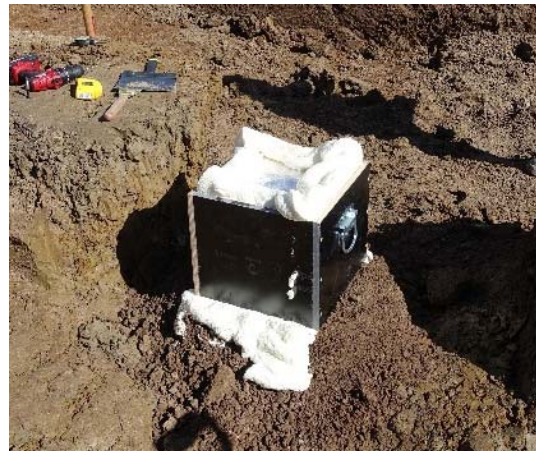
Figure C4-2: Excavated (a) and partially boxed undisturbed block sample (b)

Using hand digging tools the 'pillar' was progressively excavated to leave a neatly trimmed column approximately 300 mm square and 450 mm high (Figure C4-2a). The column was then wrapped with plastic wrap and aluminium foil to preserve the in situ moisture content. A box constructed of 17 mm thick ply was placed around the column and the annulus between the sides and lid of the box and the soil column was filled with an expanding polyurethane foam (Figure C4-2b). Once the foam had set, the sample was then undercut, inverted, trimmed, sealed with plastic wrap and aluminium foil, filled with foam and the base of the box screwed on.

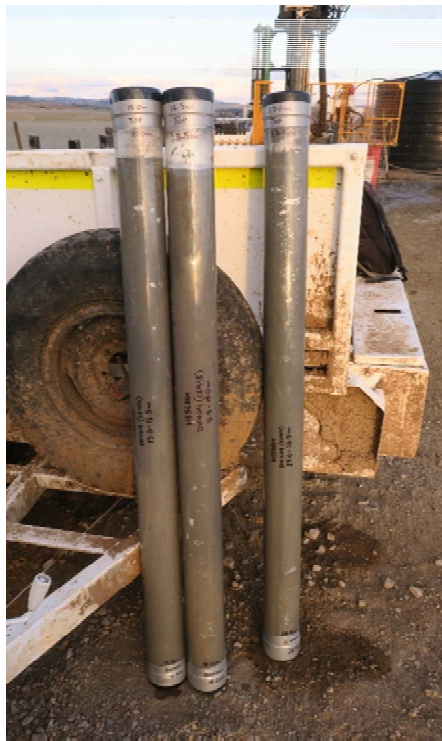
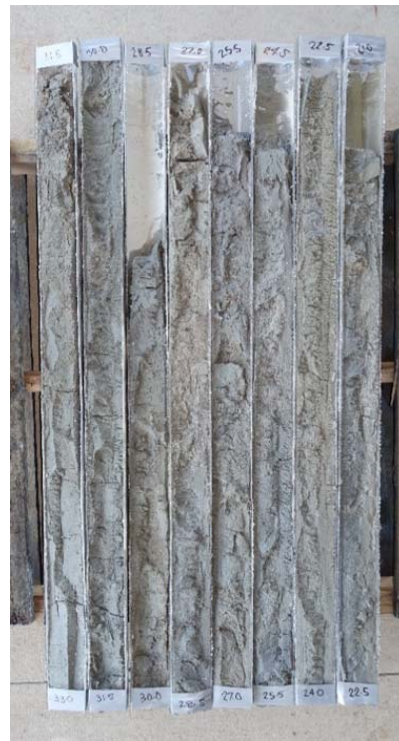
Figure C4-3: Lexan tailings samples

Lexan tailings samples were maintained in a vertical position on site (Figure C4-3a) and during transport to the CVO core processing facility (CPF). At the CPF a selected number of Lexans were split longitudinally using a jigsaw and 'torn' apart to exposed any structure or layering. One half of the Lexan was sub-sampled and sealed in a plastic sleeve while the other was air dried (Figure C4-3b) to expose sandier horizons (if present).

(a) Lexan samples stored at drill site

(b) Lexan samples split and air dried

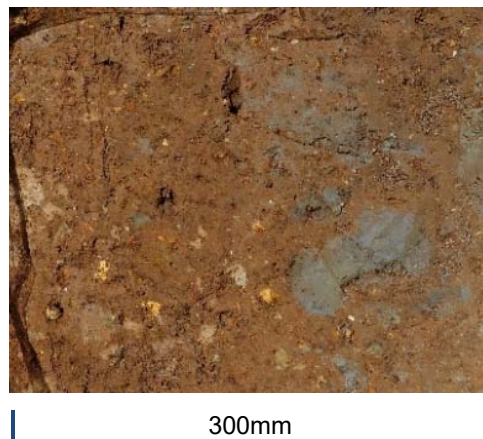
Figure C6-1: TP401 BL01 @ 1.0m

The residual basaltic soil typically graded into extremely weathered basalt. Figure C6-1 shows residual, red brown basaltic soil (high plasticity CLAY with some sand and gravel) with 50-100 mm diameter corestones of grey, extremely weathered basalt. A further 0.6 m below this sample, the basalt transitioned to highly weathered, then slightly weathered to fresh basalt a further 0.5 m below.

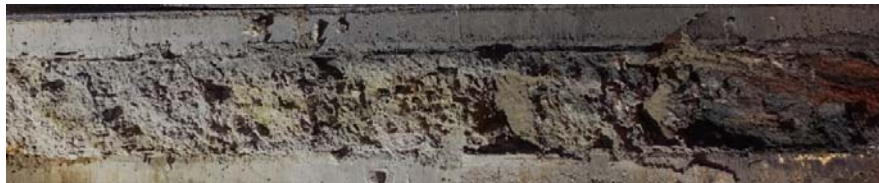
Figure C6-3: CE417 16.50 - 17.00m- low energy paleo alluvium

Upper 1.3 m	Clayey SILT, high plasticity, light grey with red brown staining, block structure.	Figure C6-3
Centre 3.0 m	Silty CLAY, high plasticity, black, organic matter and sulphurous odour indicate anaerobic conditions. Organic content 7%.	Figure C6-4
Bottom 1.3 m	Silty CLAY, high plasticity, light grey with orange mottling, fissured.

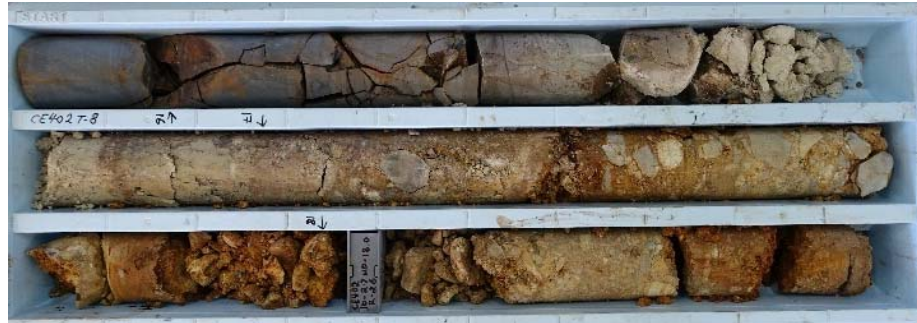
Figure C6-5: CE402 15.80 – 18.60 m - high energy paleo alluvium

In contrast to the low energy, lacustrine or fluvial overbank deposits, seen in drillholes CE416 and CE417, paleo alluvium in CE402 is comprised of subrounded gravels in a sandy matrix (Figure C6-5) and are characteristic of a high energy environment. The gravelly alluvium in CE402 is both overlain and underlain by light grey Silty CLAY, resulting in a thickness in excess of 3 m.

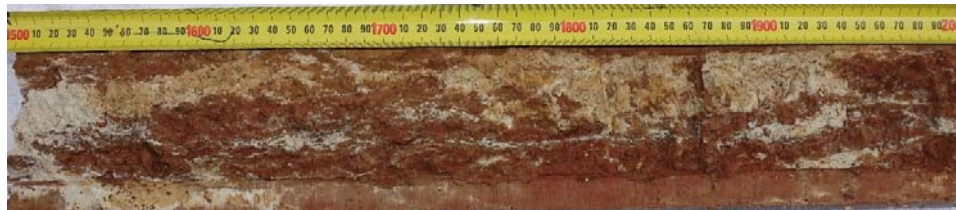
Figure C6-10: CE416 24.50 – 25.00m – residual paleosoil developed over FRV

The transition from residual paleosoil to extremely weathered FRV can be seen in drillhole CE416, where residual red orange clayey SILT with white (kaolinite?) veining is evident in Figure C6-10 and white speckled and white veined extremely weathered FRV can be seen in Figure C6-11.

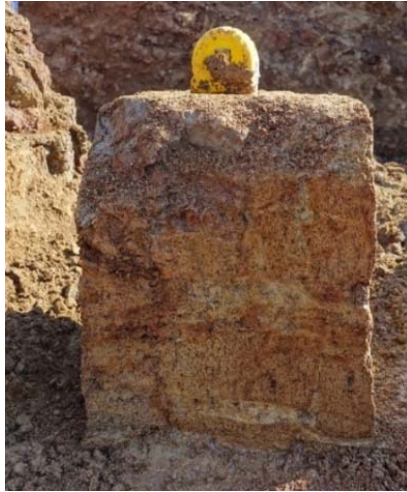
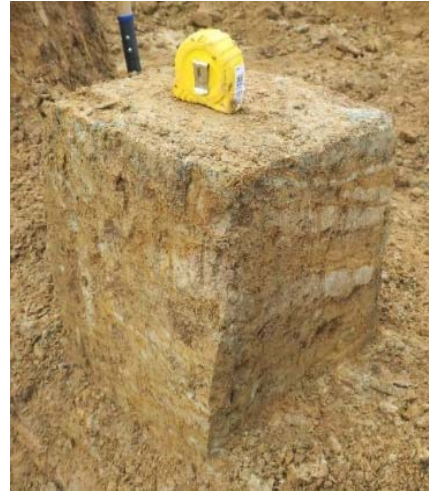
Figure C6-12: FRV Unit B; Block samples recovered from test pits TP403 and TP405.

Unit B is typically Sandy CLAY or Silty CLAY with some sand and weathered rock fragments, medium to high plasticity and red orange to yellow brown as indicated in Figure C6-12.

TP403 BL01, 1.5 – 1.8 m

TP405 BL01, 1.9 - 2.2 m

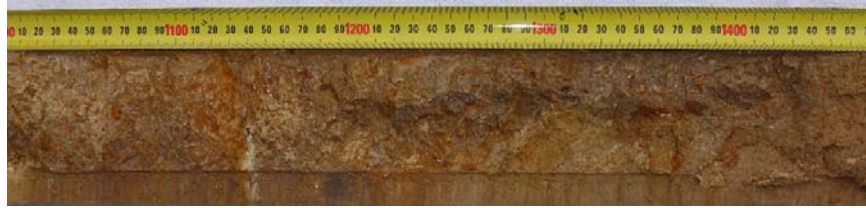
CE411A 16.00 – 16.55m

Clayey SILT, medium plasticity, yellow orange with purple staining and red orange staining, white speckling PP = 500 to +600kPa.

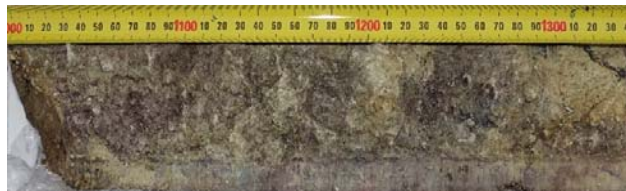
CE412 62.00 – 62.35m

Clayey SILT – medium plasticity, greenish grey with some purple staining and white speckling, fine grained clasts of green grey / purple tuff. PP = 500 to +600kPa

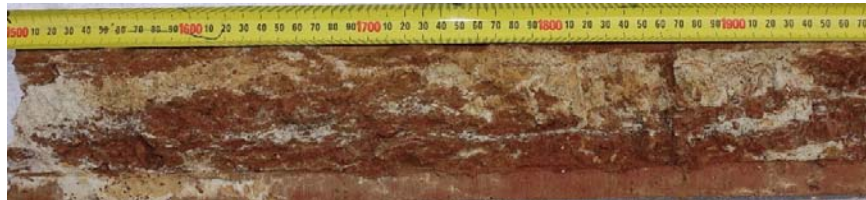
CE416 24.50– 25.00m

Silty CLAY, medium to high plasticity, red orange with yellow white veining and some black staining of fissures, PP = 450 to 500kPa in red, 260 to 300kPa in yellow white.

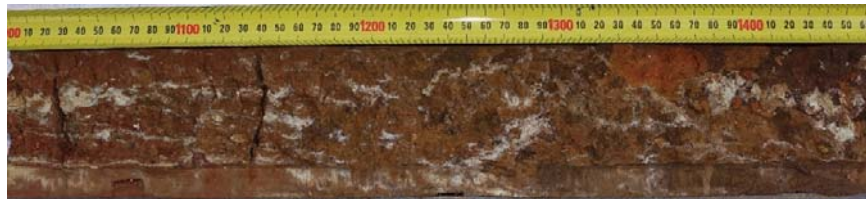
CE416 25.00 – 25.50m

Clayey SILT, medium to high plasticity, red orange to red brown with white veining, possibly relict pyroclastic texture at base, an absence of mottling. PP = 230 to 330kPa.

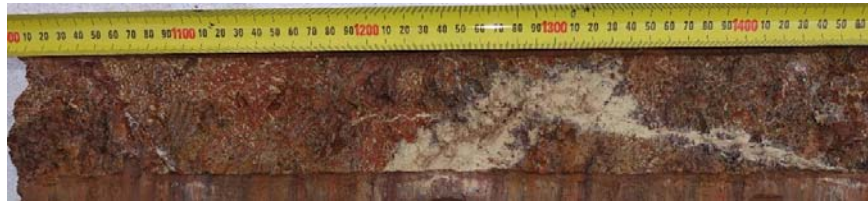
**CE416** 26.00 – 26.50m

Silty CLAY, medium plasticity, red orange with yellow white and white, moist Clayey SILT veining and speckling, trace of purple staining. PP = 280 to 360kPa in red orange, 170 to 200kPa in yellow white.

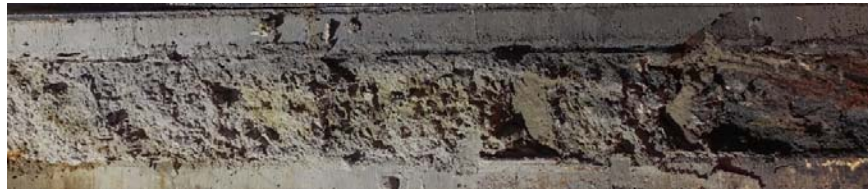
**CE417** 16.50 – 17.00m

Silty CLAY, high plasticity, light grey with some green grey veining, blocky structure with some slickensided fissures, becoming dark grey below 16.85m.

Below 16.90m , black with some white veins and speckling. Organic matter 25mm dia with vascular structure still evident.

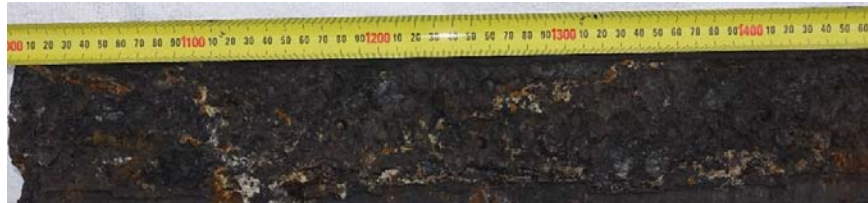
**CE417** 18.00 - 18.50

Silty CLAY, high plasticity, black with white and ferruginous staining along relict fissures, slight sulphurous odour, PP = 310 to 350kPa.

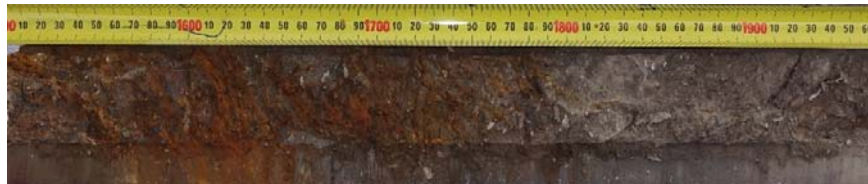
**CE417** 20.50 – 21.00

Silty CLAY, medium plasticity, initially grey with orange ferruginous banding, becoming light grey and fissured below 20.70m. PP = 550 to 600kPa.

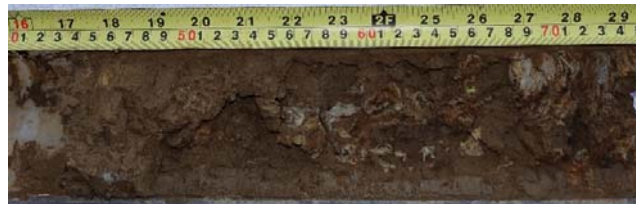
**CE432** 22.40 – 22.75

Sandy CLAY, high plasticity, fine grained sand with a trace of fine gravel, brown with grey white extremely weathered relict rock fragments <15mm dia.

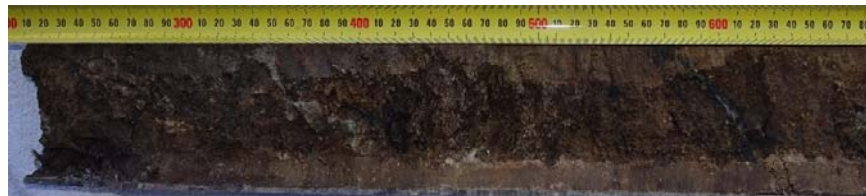
**CE433** 33.20 – 33.80

Volcaniclastic, extremely to highly weathered, light brown with green, orange and black speckling, with some black staining along relict joints. Breaks down into Clayey SILT, low plasticity, with trace of fine sand. PP = +600kPa Single piece of gravel at top, 15mm dia, basaltic?

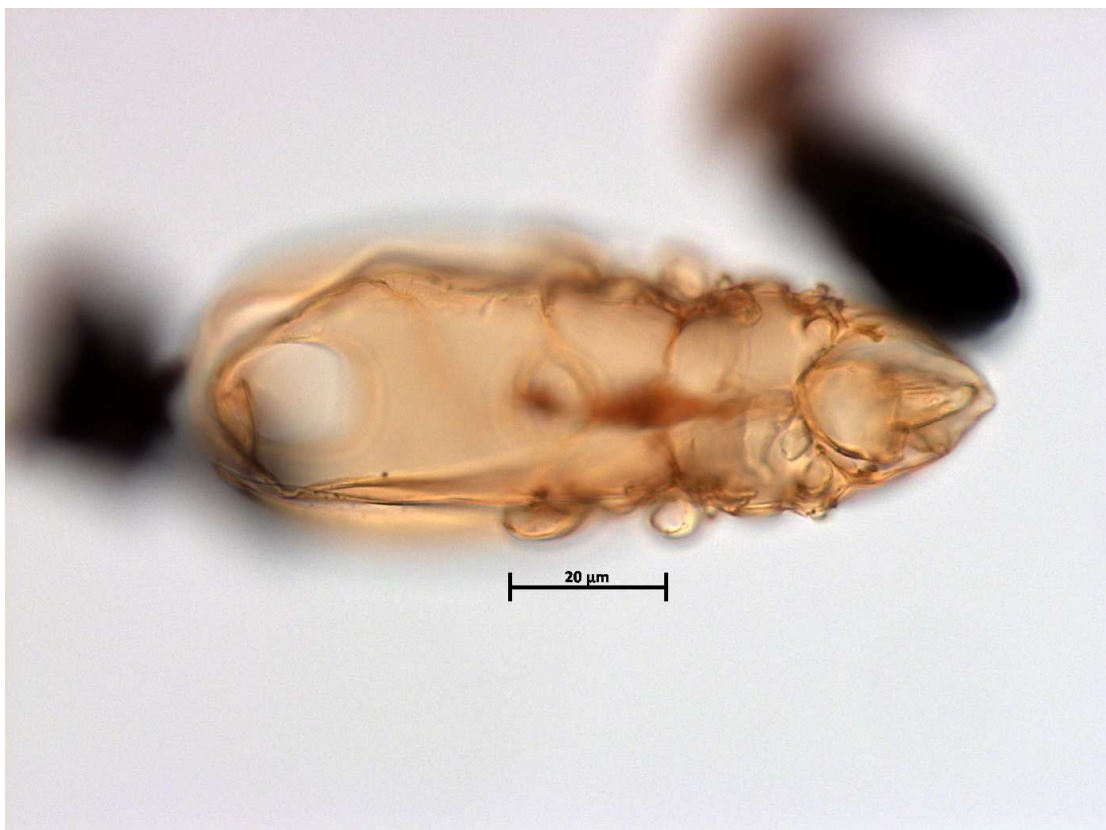
Sub-fossil corpse of an unidentified insect identical to those recovered from 16.5 m depth in CE417

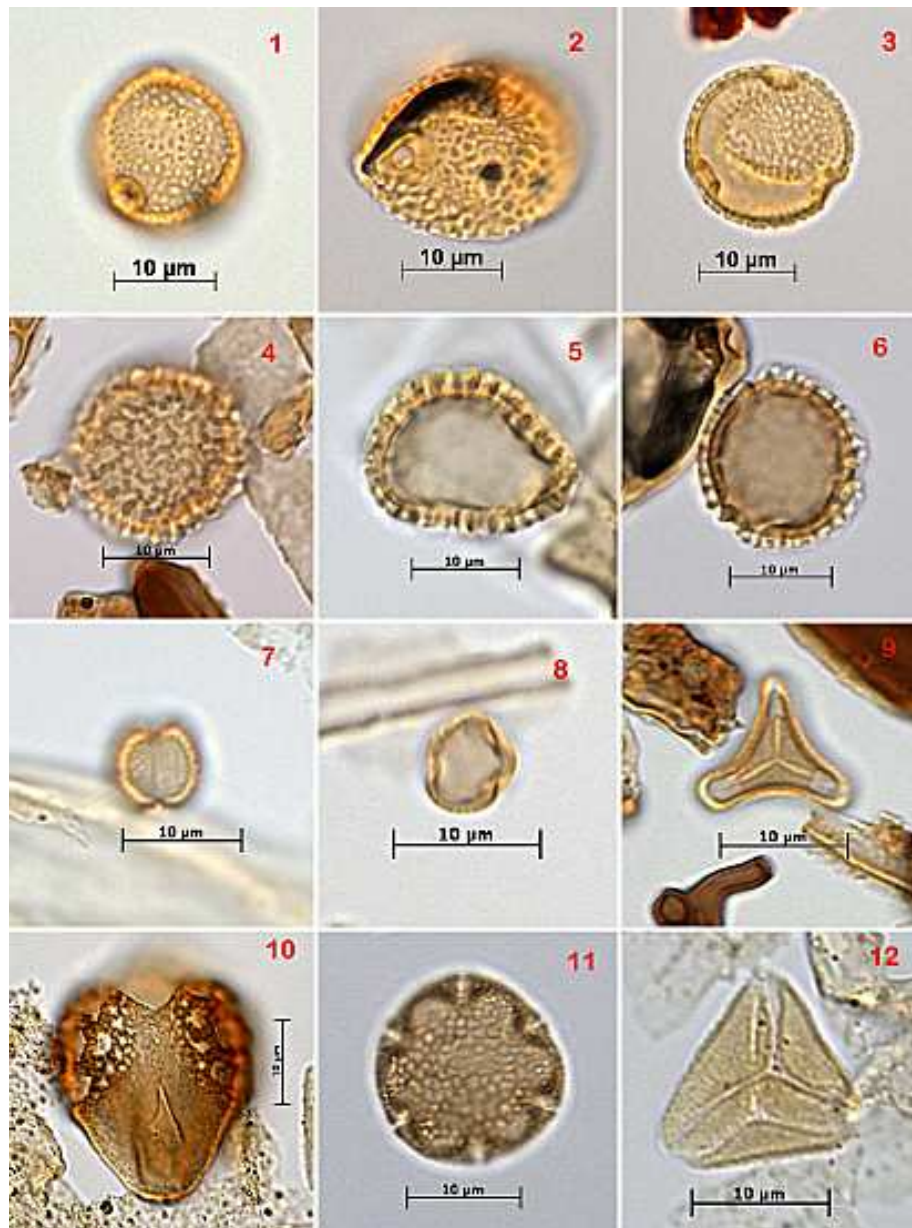
Fig. 5: Fossil pollen and spores preserved in a *c.* 23 Ma claystone from Toowoomba (from Macphail & Gibson 2104).

Pollen analysis confirms that clays and claystones interbedded with volcanic and volcanoclastic deposits elsewhere in eastern Australia can preserve abundant fossil pollen and spores, which in turn can be used to date the sediments. Examples from claystones between two independently-dated (c. 23 Ma) basalts exposed during construction of the Toowoomba Main Range By-pass in Southeast Queensland are reproduced in [Fig. 5](#).

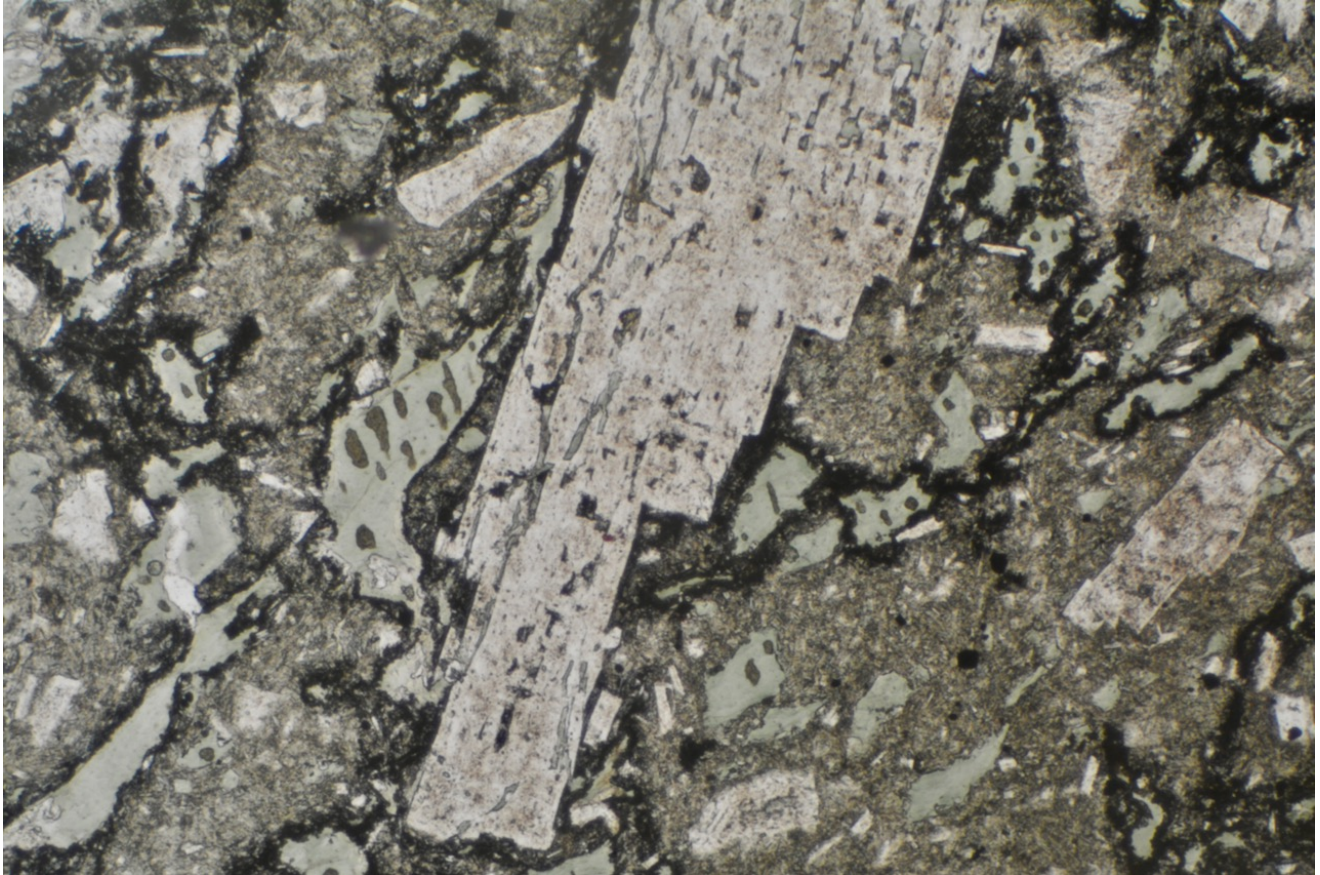
CE405-29.7m – e – same view as previous photo in ordinary light to highlight the amount of chlorite in the groundmass. Scale: side of photograph is 1.6mm

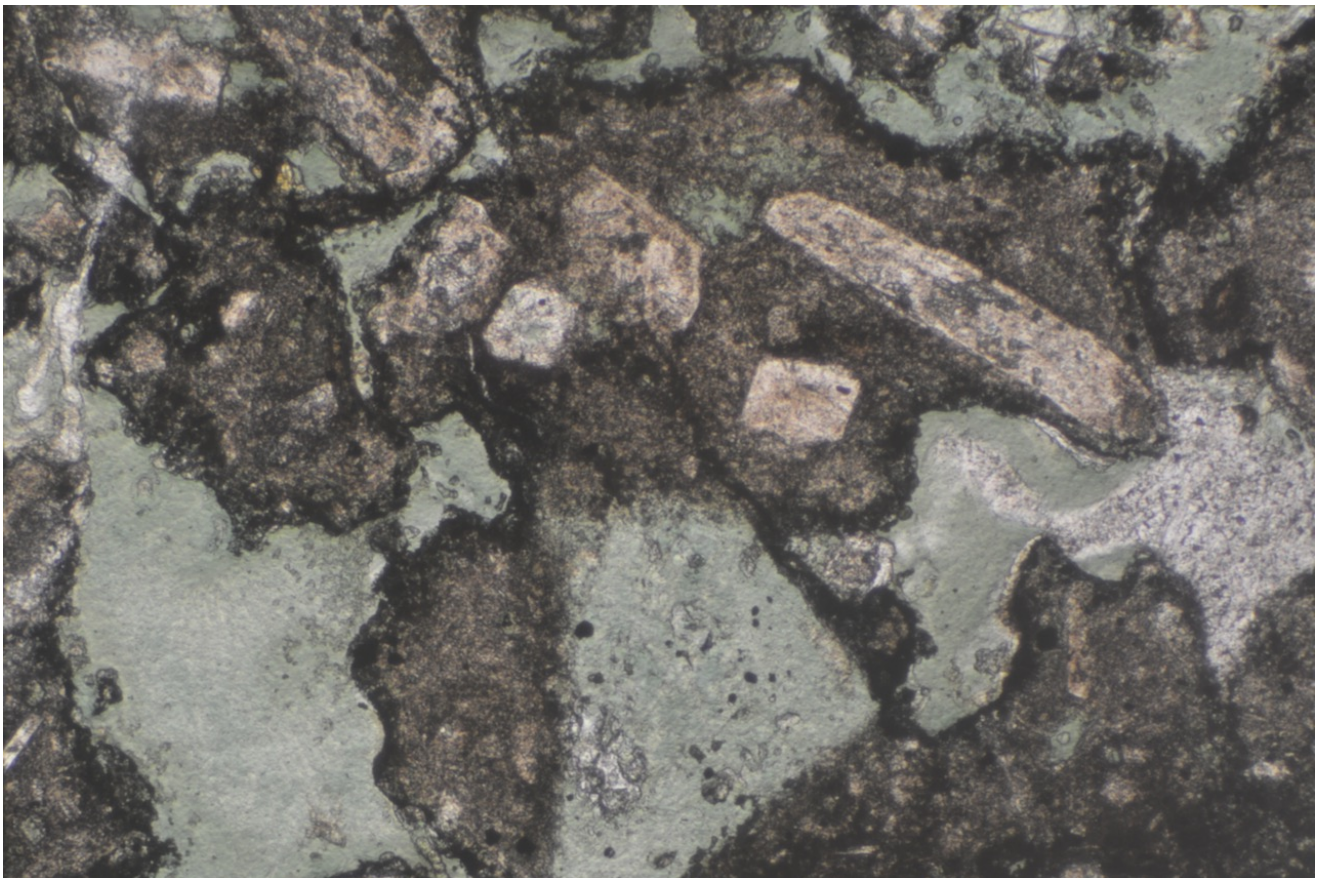
CE405-29.7m – j – another section of rock containing much larger patches of chlorite in a dense groundmass. The whitish patch at centre right is calcite. Scale: side of photograph is 1.6mm

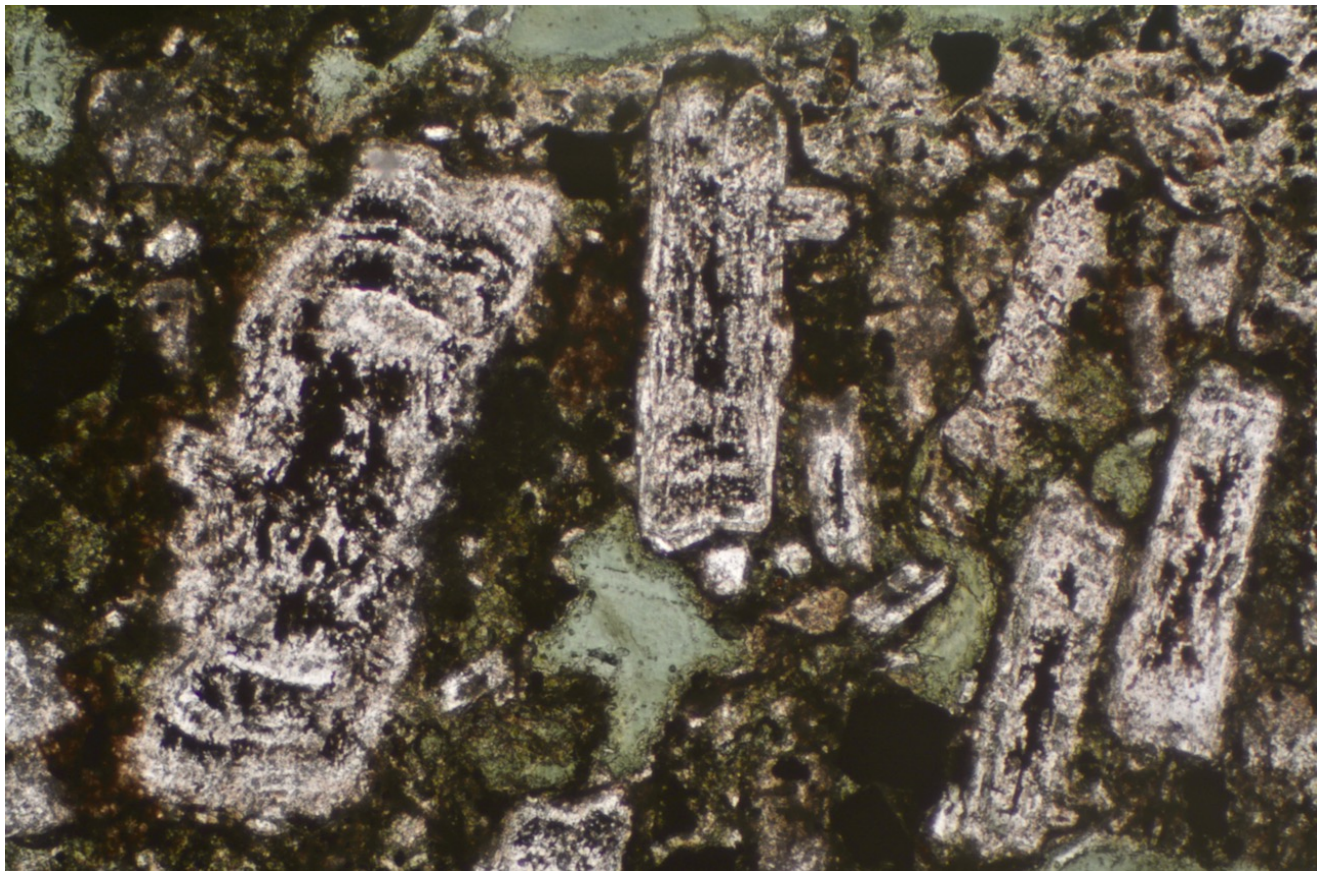
CE409–42.3m a - a common textural view in ordinary transmitted light of this volcanic rock showing some characteristic textures of the feldspar phenocrysts. Note also the numerous patches of green chlorite. Scale: side of photograph is 1.6mm
