Report on NTSF Embankment Failure

Cadia Valley Operations

Independent Technical Review Board

Date: April 17, 2019

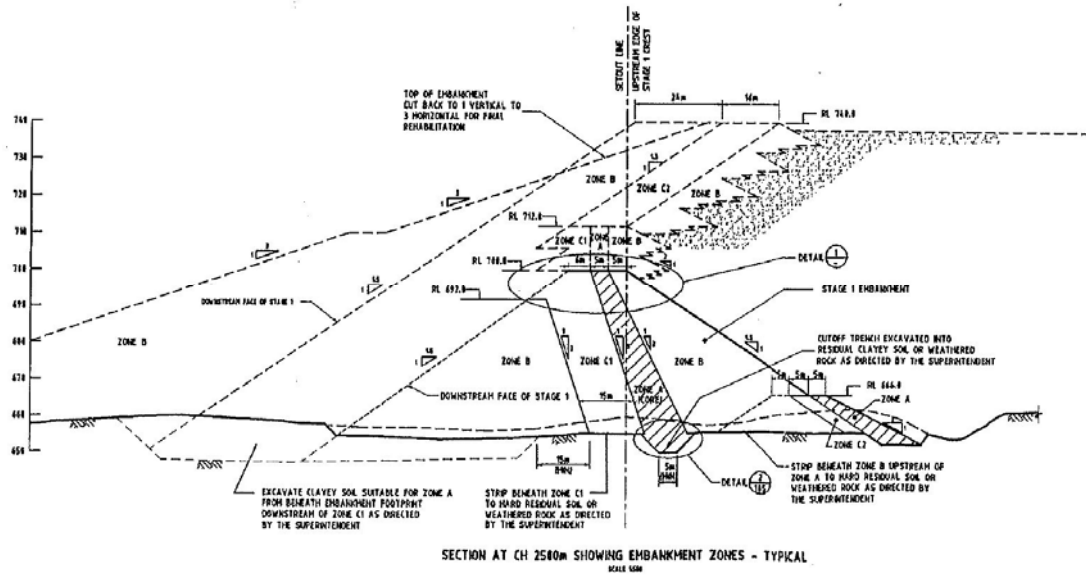
Figure 3-1: Original ultimate design concept using modified centreline construction (1997-001)

It is noteworthy that the design implemented from Stage 4 to Stage 9 differed significantly from that initially proposed at Stage 1, as shown in Figure 3-1.

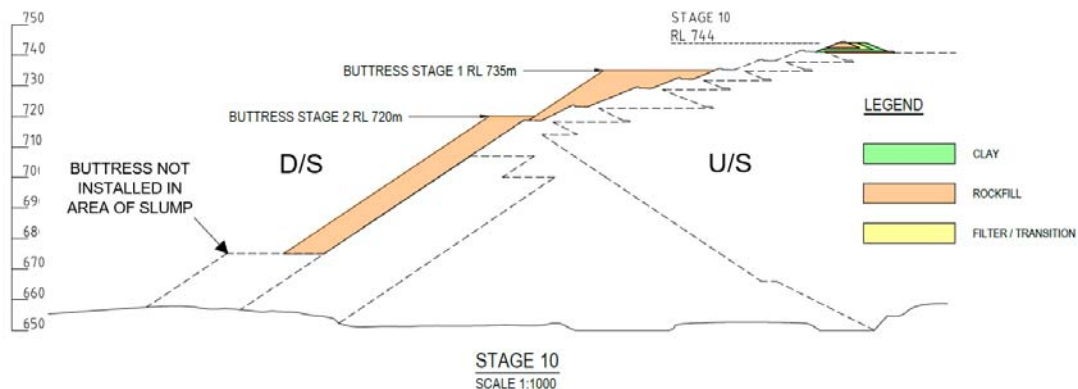
Figure 3-6: Stage 10 Embankment Configuration

However, following a campaign of cone penetration tests in 2017, the designers concluded that the overall strength parameters, when used in stability analyses, resulted in Factors of Safety that were too low. As a consequence, they recommended the construction of two buttresses to achieve acceptable Factors of Safety under both static and dynamic loading. The two buttresses, referred to as Stage 1 Buttress and Stage 2 Buttress, are shown in Figure 3-6 together with Stage 10. The buttress that is shown to be supporting the Stage 2 Buttress did not exist in the slump area.

As part of the Stage 10 design, the designers concluded that Factors of Safety were too low and recommended the construction of two additional buttresses (see Figure 3-6). The Stage 1 Buttress was completed in the vicinity of the NTSF embankment failure by March 6, 2018. Stage 2 construction had not started in the slump area at the time of the Event, but stripping of more than 4 m had been undertaken at the toe of the dam in January 2018. Hence, considerable activity associated with buttress construction preceded the Event.

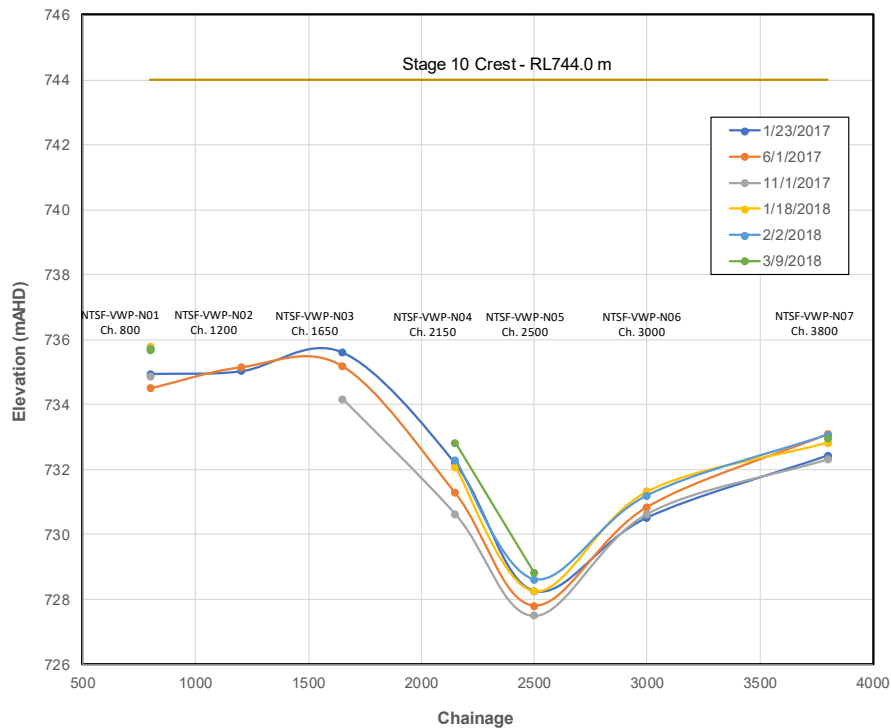
Figure 3-8: Longitudinal profile of piezometric surface with time

- piezometers on the western side of the NTSF indicate piezometric levels generally higher than the eastern side (at elevation RL 735 m); the failure zone appears to correspond with the location of relatively high pore pressure (significantly higher than the drain situated at elevation RL 714 m. (see Figure 3-8); and

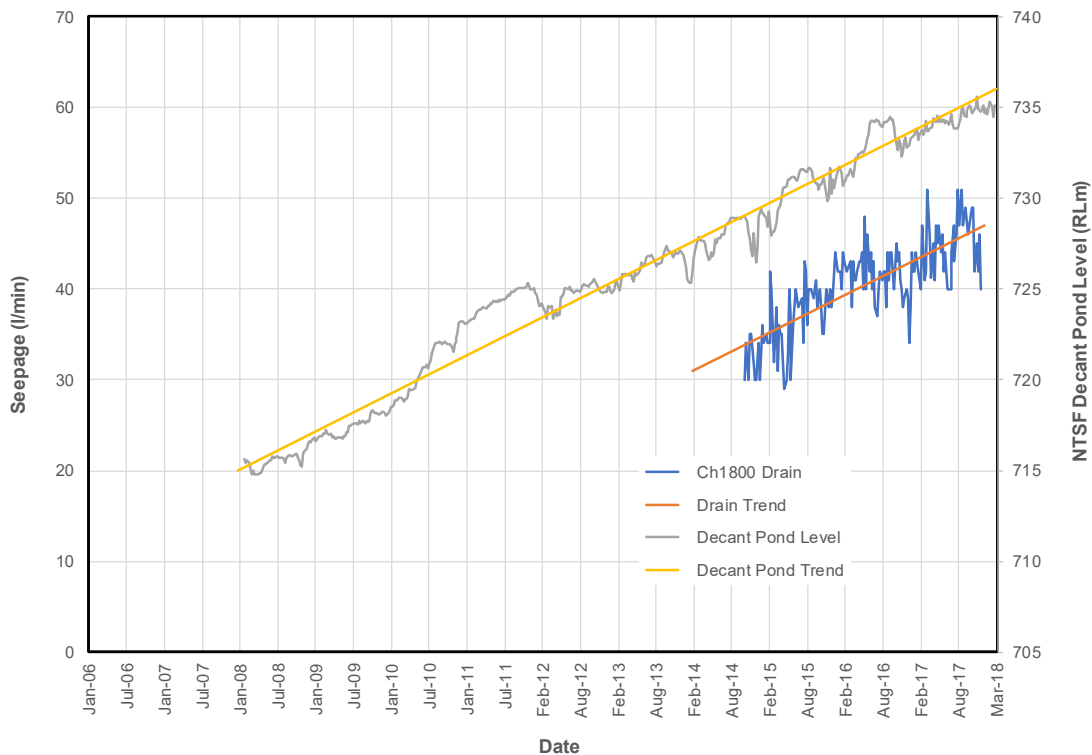
Figure 3-9: Ch1800 drain flow and NTSF decant pond level

The Stage 3 drains have generally remained dry, except for the drain at Chainage 1800 which intercepts seepage along the full length of the western embankment. Drain flow measurements between early 2015 and February 2018 range between 30 and 50 litres/minute as shown in Figure 3-9. Other observations of wet spots are summarised in Appendix B.

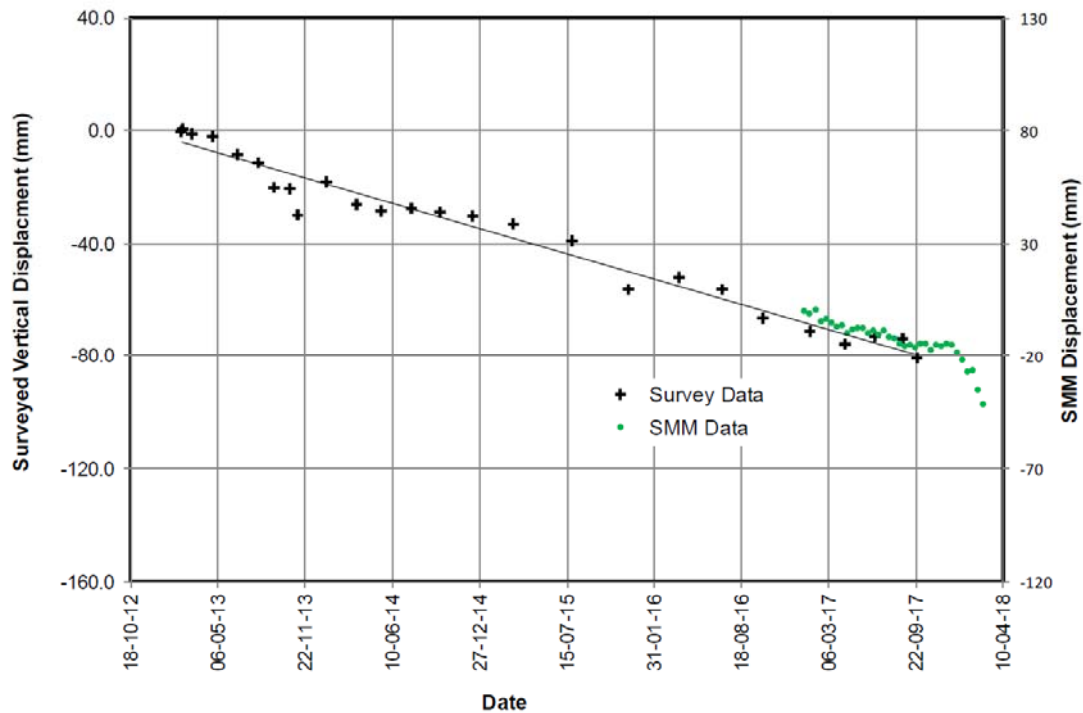
Figure 3-13: Prism 6 - Comparison of survey and InSAR SMM data

As the SMM data cannot be resolved into the three components of movement and can only be compared with terrestrial measurements in terms of trend, vertical scales on Figure 3-13 are different.

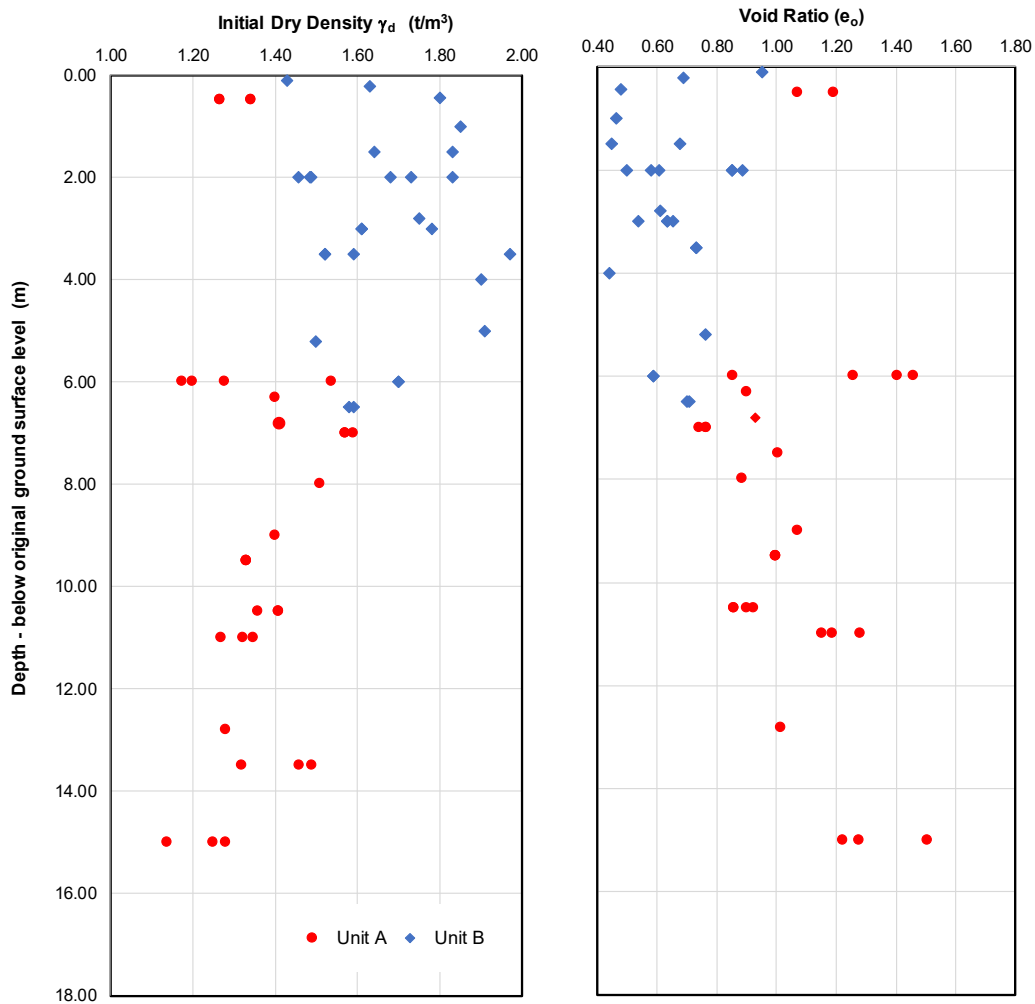
Figure 4-3: Forest Reef Volcanics – void ratio & dry density vs depth

As summarised on Figure 4-3, the insitu void ratio and density of undisturbed samples of the FRV deposit have been determined, and as indicated in the figure, the FRV Unit A is the least dense deposit with the highest void ratio.

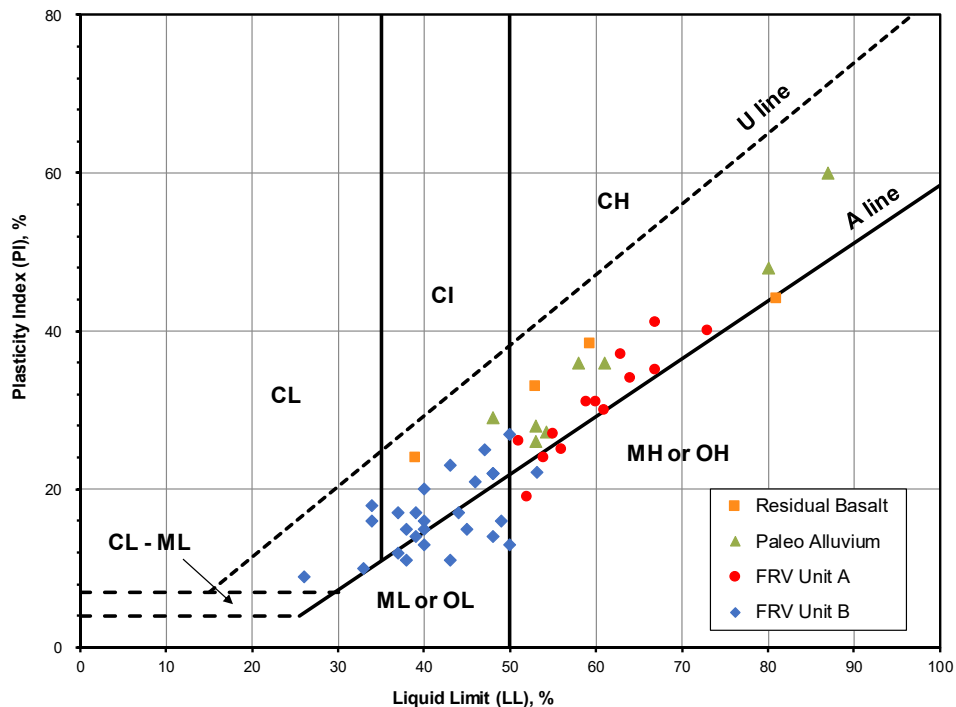
Figure 5-1: Plasticity of NTSF foundation materials

Standard index tests have been carried out on both disturbed and undisturbed samples to assess the characteristics of these materials. The results are summarised on a plasticity chart presented on Figure 5-1. A range of material are evident within any of the four strata previously identified in Figure 4-4. FRV Unit A is distinctly higher plasticity than FRV Unit B, symptomatic of its likely reduced strength.

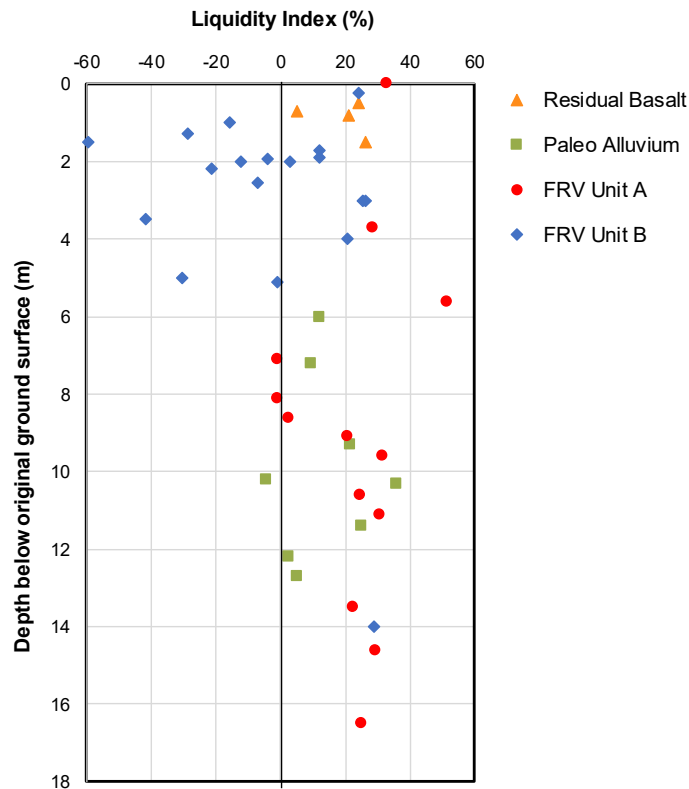
Figure 5-2: Liquidity Index vs depth

The void ratio or moisture content of a saturated soil can be related to the plasticity classification indices shown in Figure 5-1 by means of the Liquidity Index (LI). This references the potential strength of the soil to the bounding plasticity indices; a high LI indicates a weak soil, whereas a low LI indicates a stronger soil. This data is shown on Figure 5-2. There is variability in the LI in all strata, but the FRV Unit A displays both the greatest values and the greatest proportion of high values.

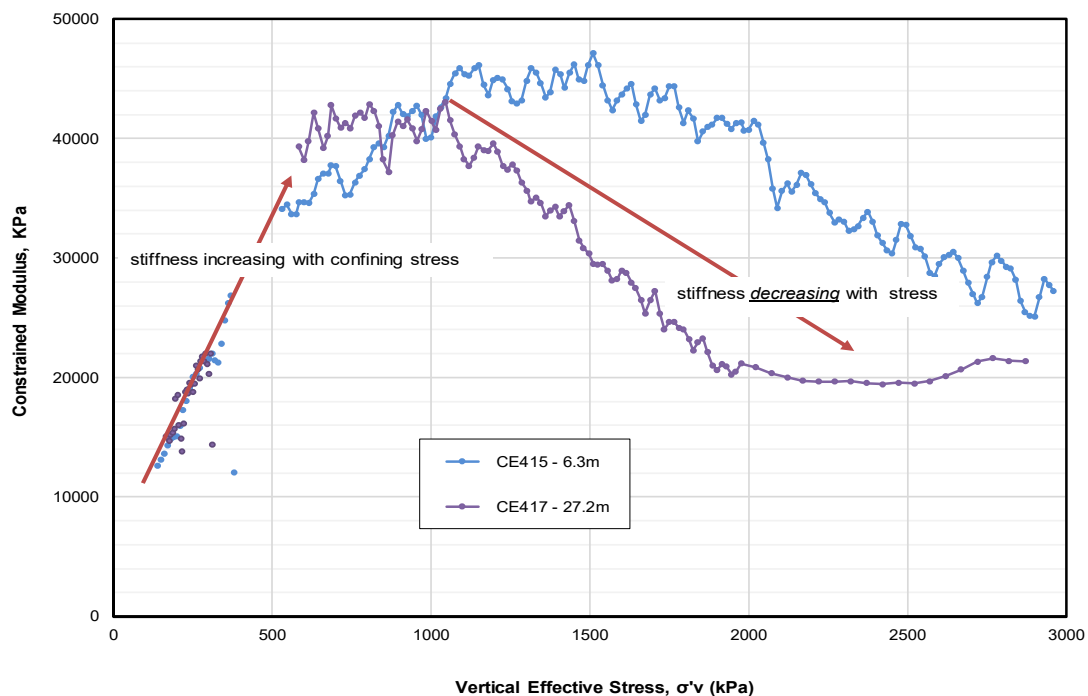
Figure 5-10: Confined compression modulus trends in FRV Unit A

The confined compression data as shown earlier (Figure 5-3) revealed trends of void ratio with imposed stress. This same data can be viewed as a confined modulus i.e. change in void ratio with change in stress, with Figure 5-10 showing the data in this form for the two CRS tests on the FRV Unit A samples. This plot is for those parts of the tests where plastic deformation developed (first loading). In this case, there are three trends seen in the data, emphasised by the red lines on the figure:

- Even at very low confining stress there is a significant stiffness with a modulus of ~6000 kPa, likely a reflection of the residual nature of the soil that has preserved some structure from the parent rock;
- As stress increases, so does the modulus, and in direct proportion; and,
- The increase in modulus peaks at a confining stress in the range of 1000 to 1500 kPa before a decrease in modulus with further loading increase develops. This is an unusual behaviour that appears to be caused by crushing of the soil particles or disaggregation.

This change in behaviour in the vertical stress range 1000 to 1500 kPa appears important as that stress range applies to the portion of the NTSF embankment that is upstream of the Stage 2 raise. Therefore, all the FRV Unit A present as part of the foundation beneath the upstream raise will have exhibited a reduction in stiffness as upstream construction was carried out.

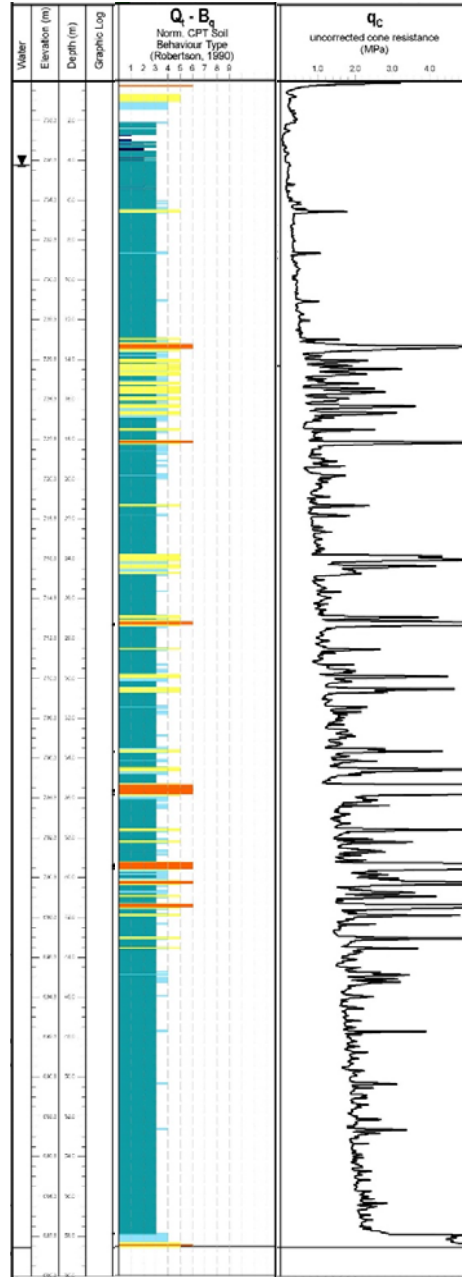
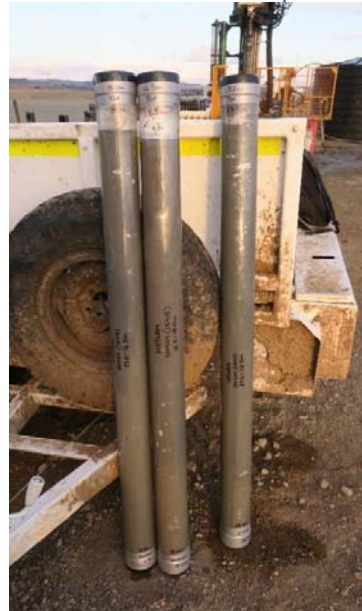
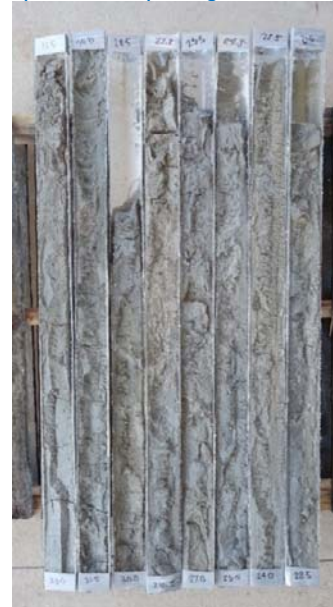
Figure 5-12: CPT-N04 and samples adjacent to the NTSF slump

The ITRB investigation included four drillholes to provide both disturbed and nominally undisturbed piston samples of tailings. The holes were drilled from the Stage 1 Buttress and Stage 10 embankment crest on either side of the slump. Figure 5-12 shows CPT-N04 (2017 CPTu fieldwork campaign) completed in the slump area and a photograph of the recovered tailings in their sample tubes from nearby drillholes. These tube samples were split and air-dried, the drying allowing visual identification of the layering within the tailings because the sandier tailings dried faster than the silty tailings; a photograph of the split tubes during air drying is also shown on Figure 5-12.

Two characteristic tailings samples were produced from examination of the split sample tubes. These were bulk samples, with sufficient tailings of each type for a comprehensive laboratory test program. Bulk sample TC1 was characteristic of the predominant silt material, which is shown as the green soil type on the processed CPTu record of Figure 5-12. Bulk samples TS1 and TS2 were characteristic of the multiple sandy silt layers, which is shown as the orange soil type on the processed CPTu record of Figure 5-12.

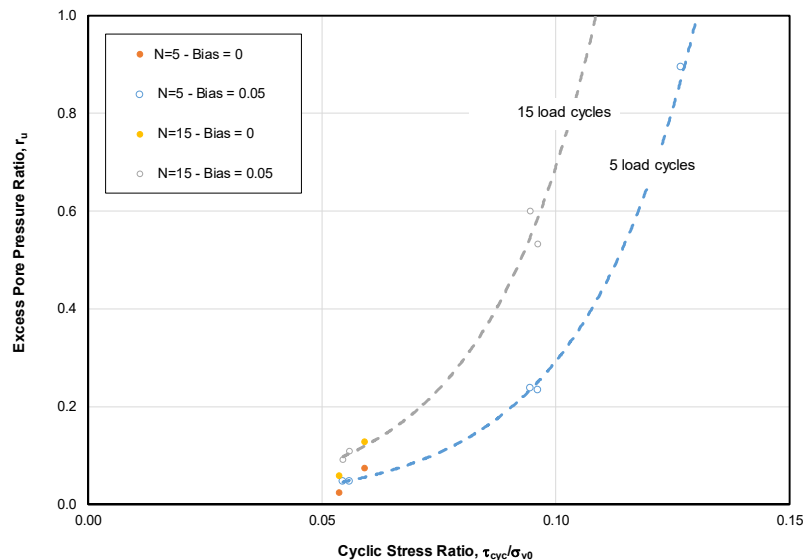
Figure 5-16: Measured cyclic response of NTSF tailings

The test data presented on Figure 5-16 has also been plotted for five load cycles and 15 load cycles. The five load cycle data is slightly more severe than experienced in the ground motion at the site for which the imposed cyclic stress ratio was about $\tau_{cyc}/\sigma'_{v0} \sim 0.05$. As soil "liquefaction" in an earthquake typically occurs at $r_u > 0.9$; the data on the NTSF tailings show a very substantial capacity under low-level cyclic loading. There appears to be minimal effect of confining stress or static bias.

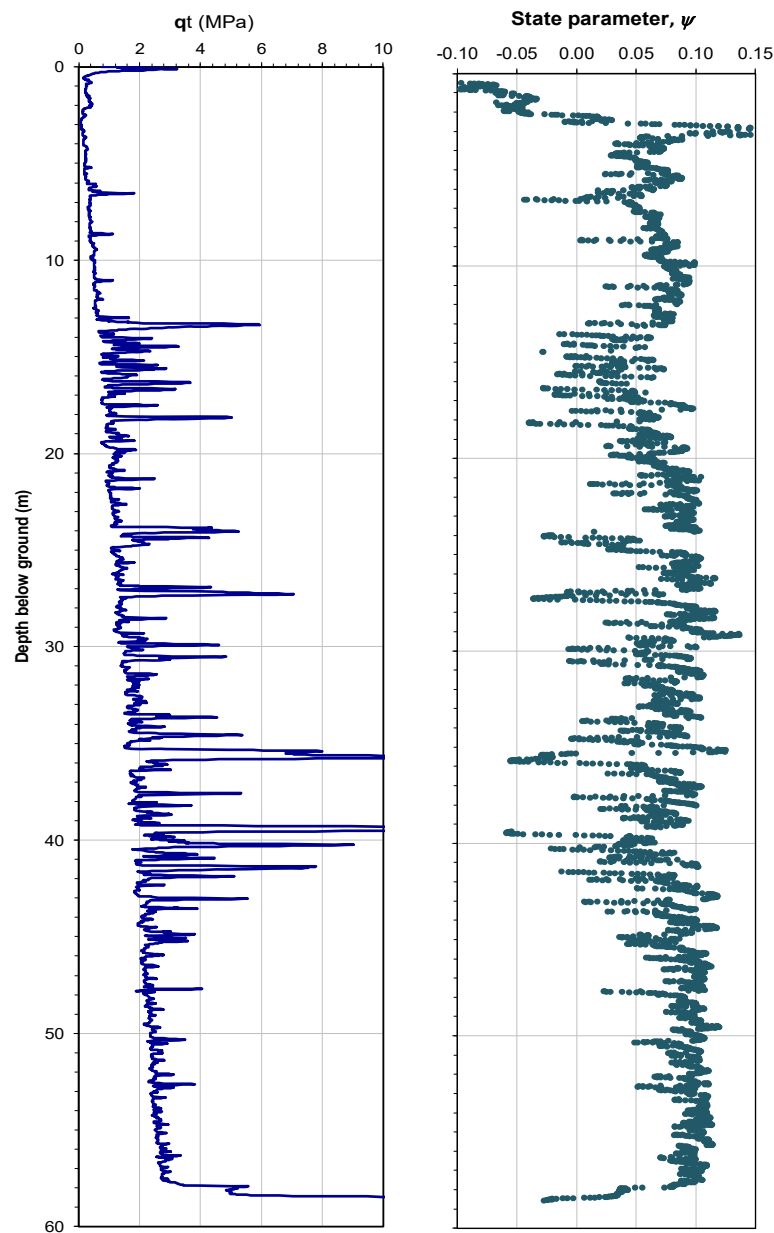
Figure 5-17: Insitu state parameter at CPT-N04

The derived calibrations have been used in processing the data from CPT-N04 and is shown in Figure 5-17. The left-hand plot shows the measured tip resistance as a visual aid in comparing the results with the features of this sounding discussed elsewhere; the right-hand plot shows the computed ψ . Details of the interpretation process are presented Appendix E.

In general, the deepest tailings appear to be slightly looser. The characteristic state parameter lies in the range $+0.08 < \psi_k < +0.10$, with the sandier layer between 13 m and 18 m depth being rather stronger.

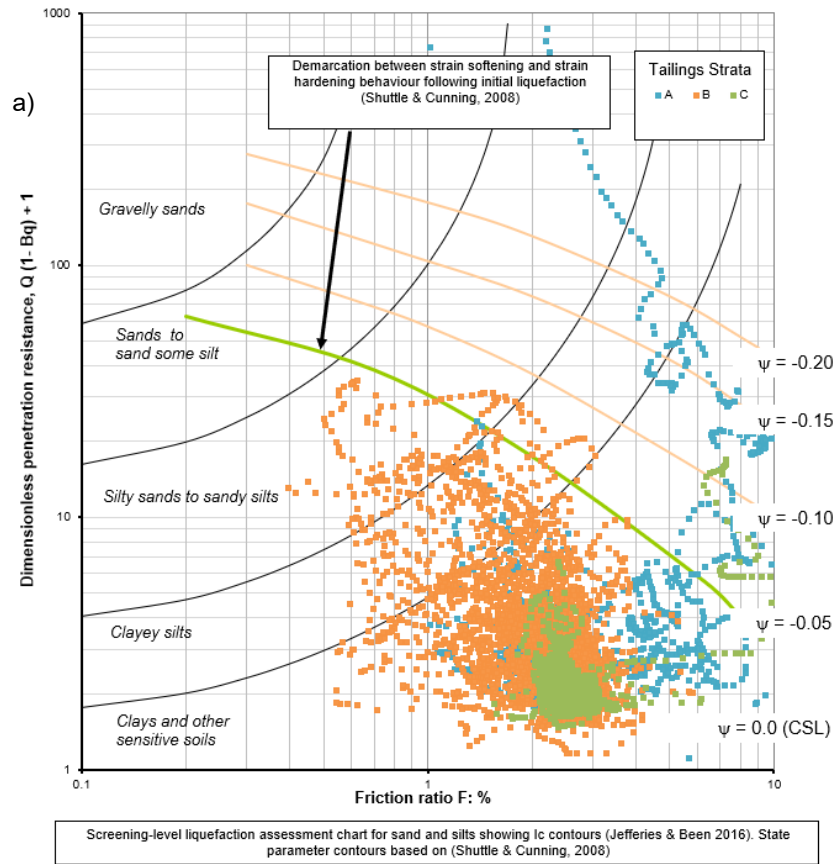
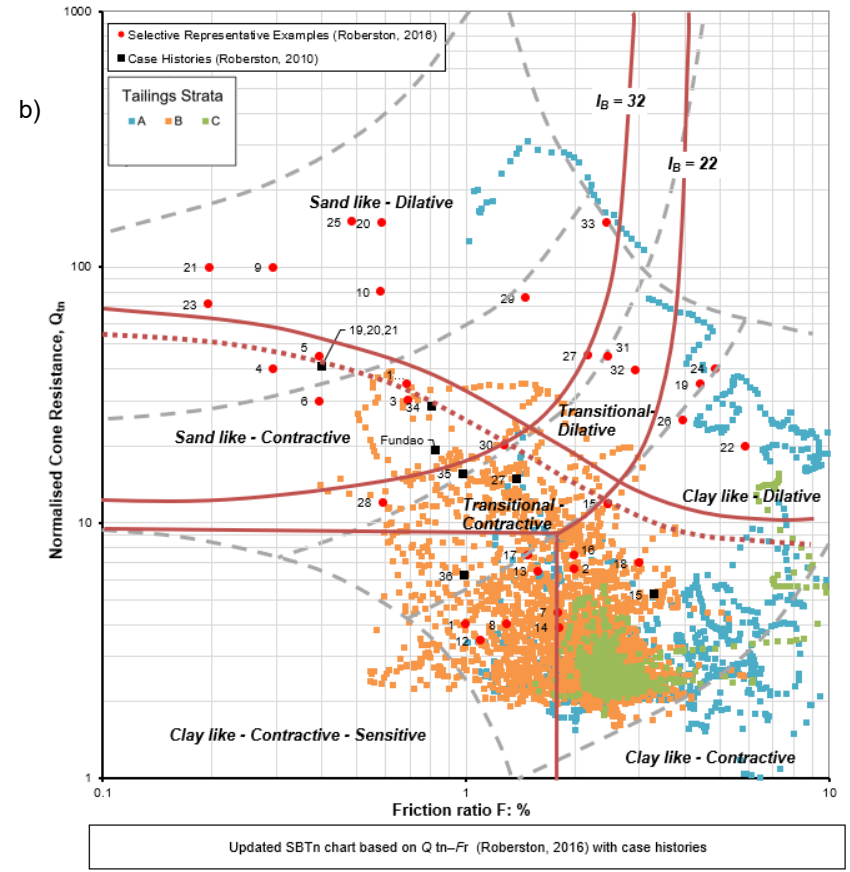
Tailings state plots are presented for CPT-N04 on Figure 5-18 using Shuttle & Cunning (2008) and Figure 5-19 using Robertson (2016). Both approaches lead to the conclusion that the NTSF tailings, as a whole, were contractive and rather weak with a clear propensity for flowslide behaviour.

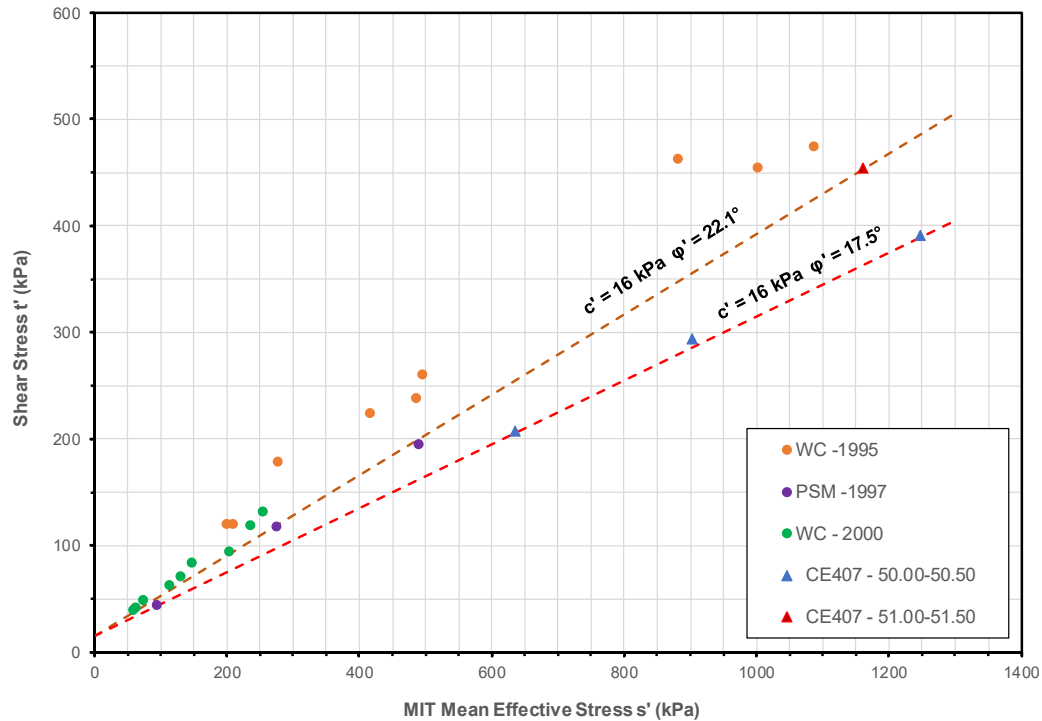
Figure 5-20: Compacted core strength in triaxial compression

Figure 5-20 compares the ITRB strength results with those from pre-construction testing. The new data (CE407 samples) shows a generally weaker core.

In the case of the compacted core, the ITRB's investigation shows systematically less strength than was expected when construction started. It is likely that part of the strength reduction is due to softening that might have happened under operational conditions. In practical terms, these reduced strengths are not a concern as the strength of the larger part of the dam (the downstream constructed part) derives from the rockfill.

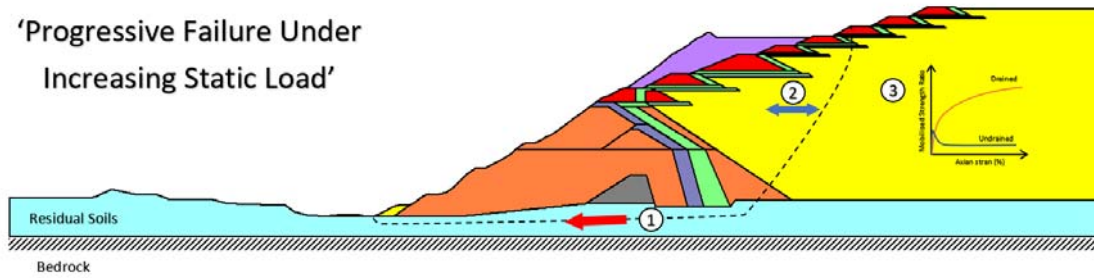
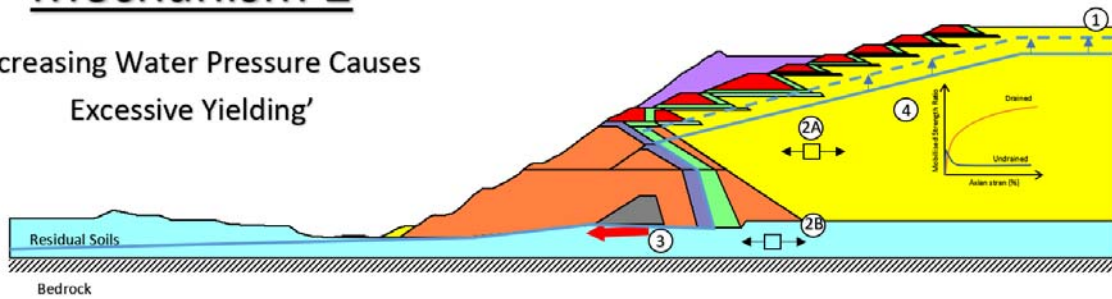
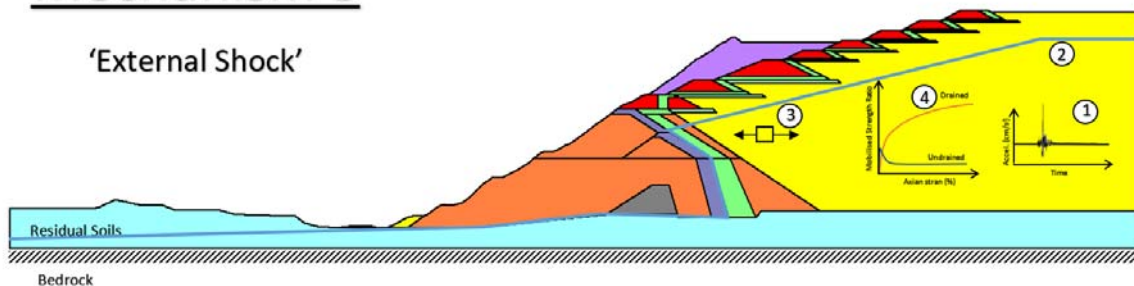
Figure 6-1: Schematic illustration of potential failure mechanisms

- (1) Progressive failure in the foundation as upstream raises cause outward horizontal movement in foundation.
- (2) Foundation movements reduce support to tailings while increasing yielding in the tailings.
- (3) When yielding in tailings progresses to the instability locus tailings rapidly switch to undrained response losing about 2/3 of their strength (Gens & Alonso, 2006).

- (1) Water table rises in the TSF as tailings level rises.
- (2) A: Rising water pressure reduces effective confining pressure in tailings.
B: Rising water pressure reduces vertical effective stress in residual soils.
- (3) Decreasing effective stresses accelerate yielding because the shear stresses remain constant.
- (4) When yielding in tailings progresses to the instability locus tailings rapidly switch to undrained response losing about 2/3 of their strength (Eckersley, 1990).

- (1) Earthquakes cause increase on pore pressures within the tailings as the particles move under the applied ground motion.
- (2) These pore pressures can trigger liquefaction on their own or can dissipate by pore water moving horizontally because of the sandier layers within the tailings and trigger liquefaction at a later time.
- (3) Migrating pore water reduces effective confining stress under the upstream raises causing yielding in these tailings.
- (4) When yielding in tailings progresses to the instability locus tailings rapidly switch to undrained response losing about 2/3 of their strength (Ishihara, Post-Earthquake Failure of a Tailings Dam Due to Liquefaction of Pond Deposit, 1984).

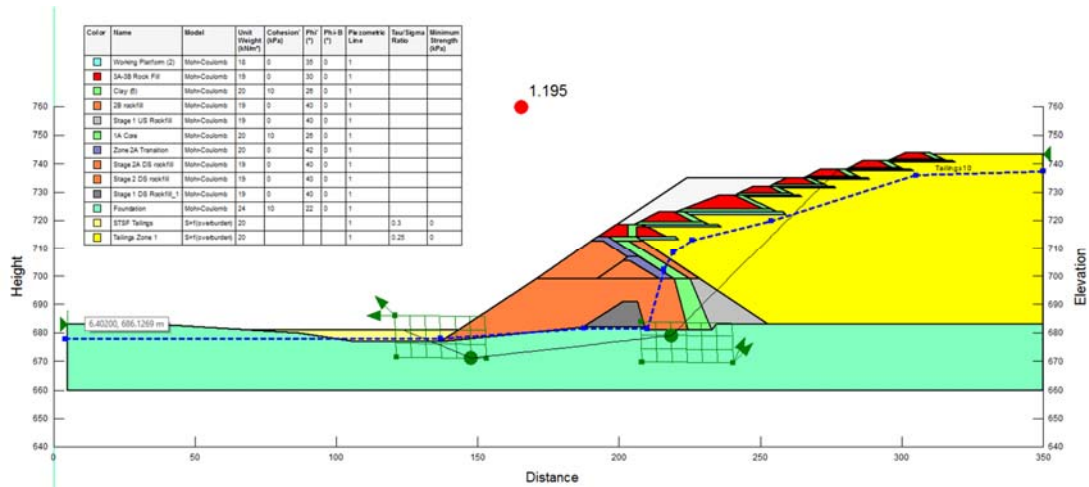
Figure 7-1: Stability section model geometry

It can be noted that a Factor of Safety of 1.2 is indicated for this case. This and many other screening calculations revealed Factors of Safety significantly less than the likely design objective of 1.5 mandated by ANCOLD, and were often close to unity. The specific numbers are not consequential to meeting the objectives of this study. However, the screening analyses did lead to several conclusions that facilitated more focused analyses such as:

- The block sliding mechanism adopted for the failure provided the lowest Factor of Safety for the design section, and a failure surface geometry that closely replicated the observed pre-failure cracking;
- The calculated Factor of Safety at the slump location is relatively insensitive to both the clay core and rockfill shear strength parameters, varying by 0.02 and 0.05, respectively, over the range of shear strength parameters analysed; and
- The calculated Factor of Safety was relatively insensitive to small variations in the assumption of the bedrock level.

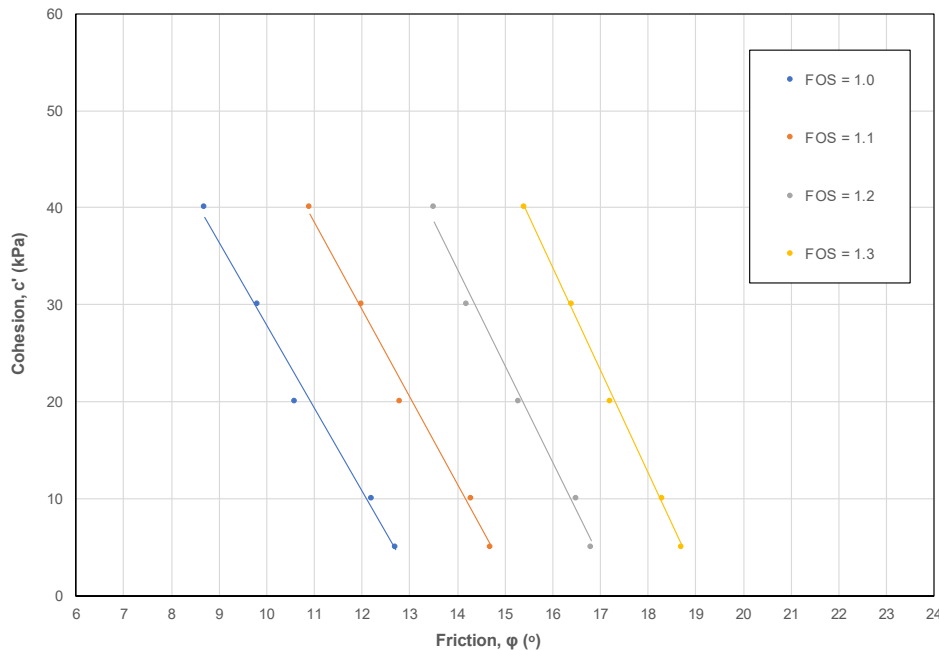
Figure 7-2: Foundation back analysis, drained tailings $\phi' = 34^\circ$

Using the combination of material parameters provided in Table 7-1, the drained parameters required to achieve a Factor of Safety equal to 1.0, 1.1, 1.2 and 1.3 were determined. The case assuming a frictional resistance for the tailings of 34° is presented in Figure 7-2. Focusing on the Factor of Safety of 1.1 results, one can infer that the average mobilised strength is less than the peak drained strengths attributable to the foundation material in Section 5 of the Report, and that little cohesive resistance was available. This implies that the lower undrained strength was likely being mobilised at this time and that progressive failure was advanced. This conclusion is helpful in guiding the formulation of the deformation analyses that one requires to demonstrate the evolution of progressive failure in more detail.

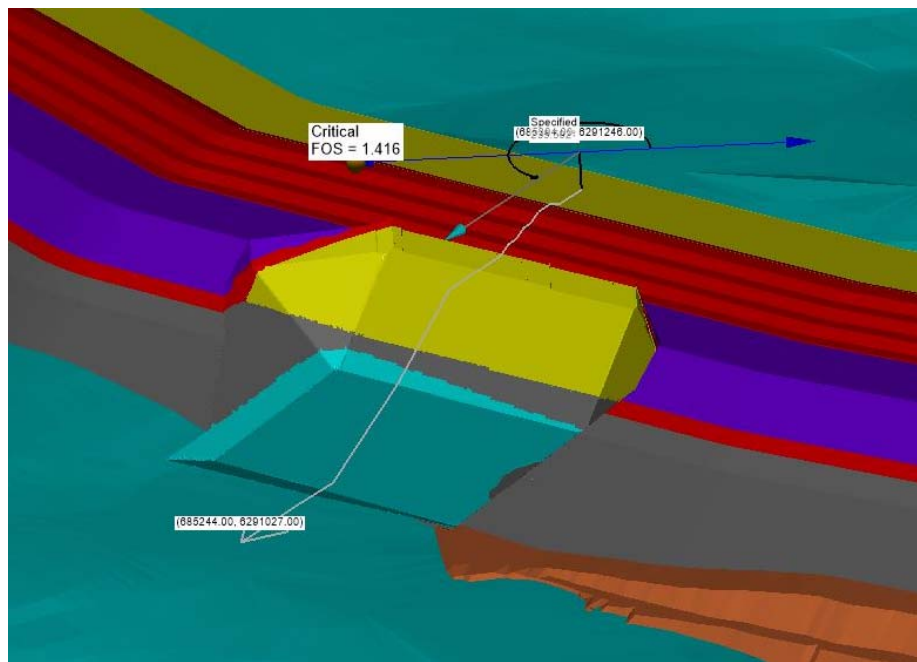
Figure 7-3: Adopted failure surface geometry

A more detailed 3D analysis was subsequently undertaken that honoured field observations in a better manner than the first trial computations. The observed vertical tension cracks were also simulated, and the phreatic surface developed in the comprehensive hydrogeological investigation presented in Appendix H were also incorporated in the analyses. Details are discussed in Appendix G and the modelled failure surface geometry, together with a cross-section of the slump, are shown in Figure 7-3 and Figure 7-4, respectively.

For fully drained conditions with foundation strength of $c' = 0$ and $\phi' = 16^\circ$, the 3D Factor of Safety approximately 1.39 should be compared with a 2D Factor of Safety of about 1.15 when interpolating from Figure 7-2. This indicates an approximate increase of about 20%, emphasising the need to take 3D factors into account in this study.

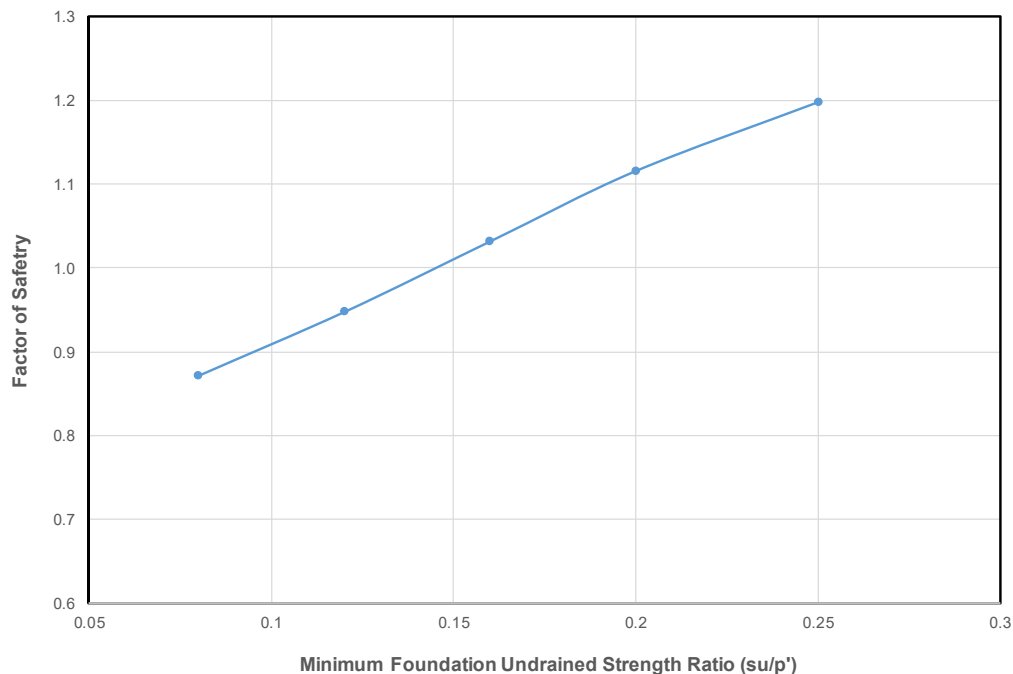
Figure 7-5: Variation in Factor of Safety with undrained strength ratio of foundation

Of particular significance is the finding that when the tailings are fully liquefied at their residual strength ratio of 0.06, and the foundation resistance is at an undrained resistance ratio of 0.22, the Factor of Safety is unity, consistent with the conceptual basis put forward for the cause of Phase 2 deformation. If the resistance ratio is put at 0.2, consistent with experimental findings, the Factor of Safety becomes 0.94, indicating the existence of unbalanced forces sufficient to accelerate the failing mass forward.

Of particular significance is the finding that, when the tailings are fully liquefied and the foundation resistance is at an undrained strength distribution consistent with the Phase 1 FLAC 3D deformation analysis, the Factor of Safety is about unity or less. The ITRB is of the view the undrained residual strength ratio of the tailings was about 0.2 at the onset of Phase 2, reducing to lower values as large deformations developed (see Sections 8.6.2.1 and 8.6.2.2). Figure 7-5 plots the Factor of Safety over a range of deduced foundation undrained strength ratios illustrating the potential for Factors of Safety less than unity, consistent with the acceleration that developed at the outset of Phase 2.

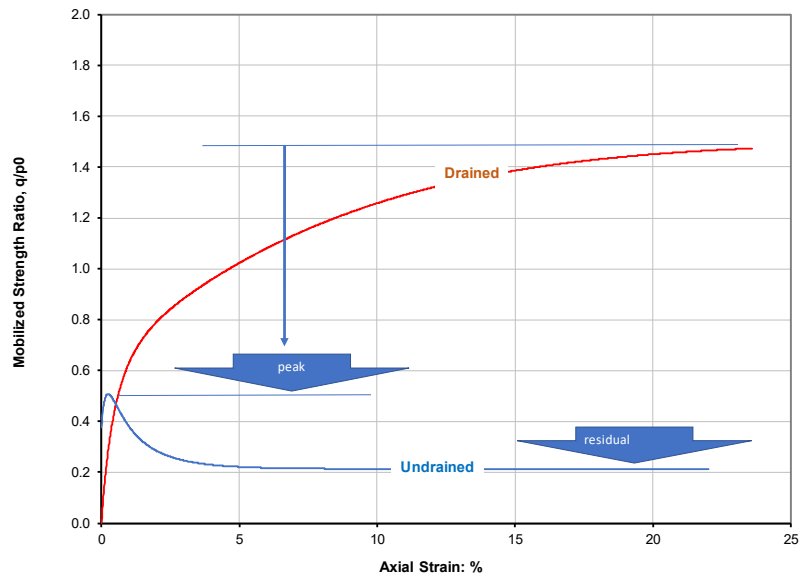
Figure 8-1: Illustration of tailings strength evolution with strain (typical for NTSF)

The controlling tailings behaviour is illustrated on Figure 8-1 and is presented here to illustrate why it was necessary to do the analyses presented in this section. Tailings behaviour depends on the loading path and the tailings ψ , with Figure 8-1 being for the approximate loading path of the most vulnerable part of the tailings at their insitu conditions in the NTSF. Figure 8-1 is schematic, but also a fair representation of measured behaviour.

The upper curve on Figure 8-1 (in orange) is the situation where the tailings are loaded sufficiently slowly for the pore water to migrate out of the tailings as they compress under load ie. drained conditions. The design of the upstream raises and Stage 1 Buttress was essentially consistent with this mode of tailings behaviour, with standpipe piezometers deployed to confirm the absence of excess pore pressures.

The lower curve on Figure 8-1 (in blue) is the situation where the pore water cannot migrate quickly enough, and which results in transfer of some load to the pore water, with consequent increase in pore pressure, ie. undrained conditions. This was the mode of the tailings behaviour during Phase 2 of the Event.

Figure 8-1 illustrates that the peak undrained strength is about one third of the drained strength, and, if strains develop in the undrained state, the strength can fall even further to a residual undrained value. This is why apparently stable dams designed for drained conditions with supposed conservative Factors of Safety can fail if something causes a change from drained to undrained response; and, because strength falls further as displacements develop, a slump will accelerate.

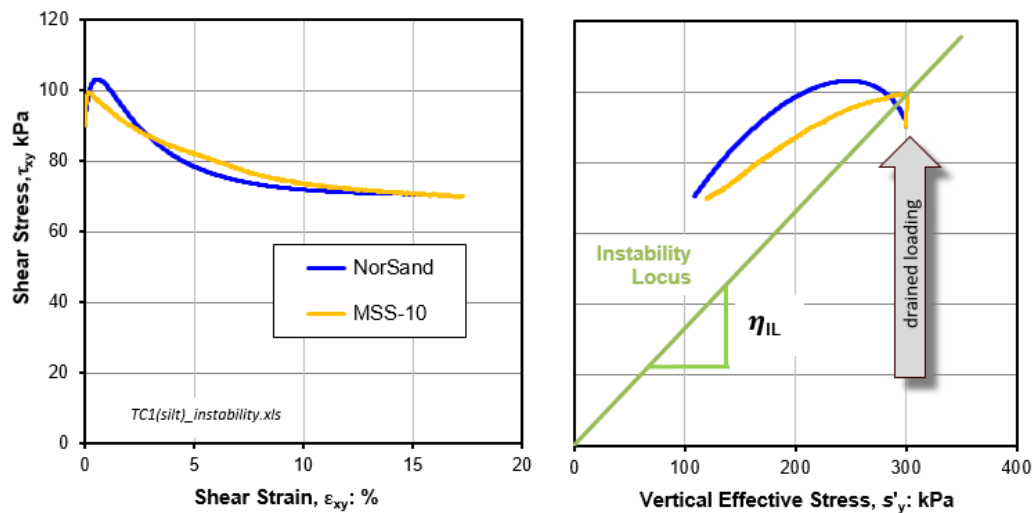
Figure 8-2: Definition of Instability Locus

The instability locus is most easily explained by test data. Figure 8-2 shows the behaviour of a loose sample loaded in direct simple shear. This test was carried out on a sample of the dominant silt tailings under stress conditions that reflect those operating beneath the downstream crest of the Stage 1 Buttress and at the level where upstream construction started. This is a critical location for embankment stability. Initially, the sample was loaded drained to the stress state reflecting the Stage 1 Buttress as-constructed. Loading then continued undrained. This test is shown on Figure 8-2 (MSS-10).

When undrained loading starts, there is some reserve strength with the sample showing a stiff response until a sudden loss of strength after the shear stress had increased by about 5 kPa. The locus defining this sudden loss of strength is represented by the green line shown on Figure 8-2. The instability locus is usually expressed as the ratio η_{IL} ($\eta_{IL} = \tau/\sigma_v$ at this condition). This test had an equivalent Factor of Safety against static liquefaction of approximately 1.05 at the end of drained loading. For other stress conditions, different stress variables are utilised, see Appendix E.

The blue line shown on Figure 8-2 is computed (using NorSand) for monotonic simple shear with the tailings properties determined in triaxial compression (see Appendix E). The computed behaviour is a reasonable match to the test, especially in the case of the stress-strain behaviour. The instability locus is also much affected by ψ , as illustrated in Appendix E.

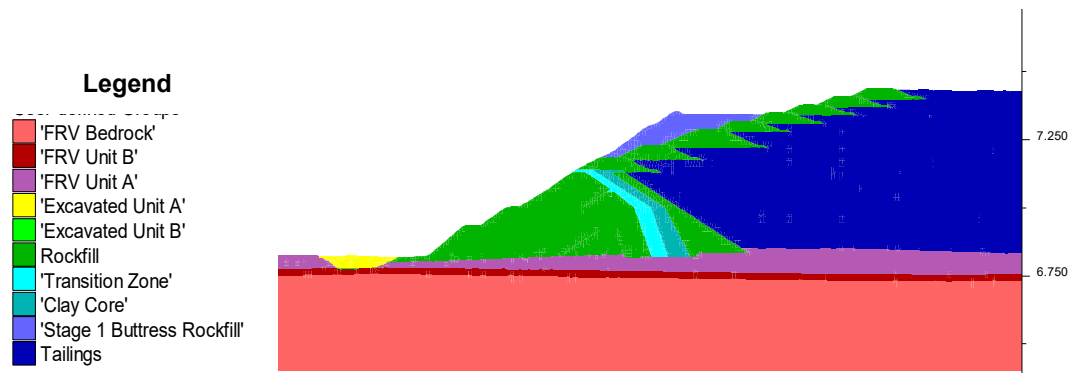
Figure 8-3: Idealisation of the NTSF embankment at CH1950 for numerical analysis

The material zones simulated in the dam were slightly simplified from the construction drawings. The internal zonation details of the NTSF dam (rockfill shell, clay core, and the transition zone) were included in Stage 1 and 2, of the model. For Stage 3 to 10, each stage was modelled as rockfill as the dimensions of the transition zones were insignificant compared to the rockfill. Figure 8-3 shows the distribution of the various zones represented; the tailings extend for 500 m upstream of the dam core to allow full development of the extent of liquefaction unconstrained by boundary effects. The fill and foundation elements were grouped to allow sequencing of staged construction and to include inter-stage excavation or deposition downstream of the dam toe.

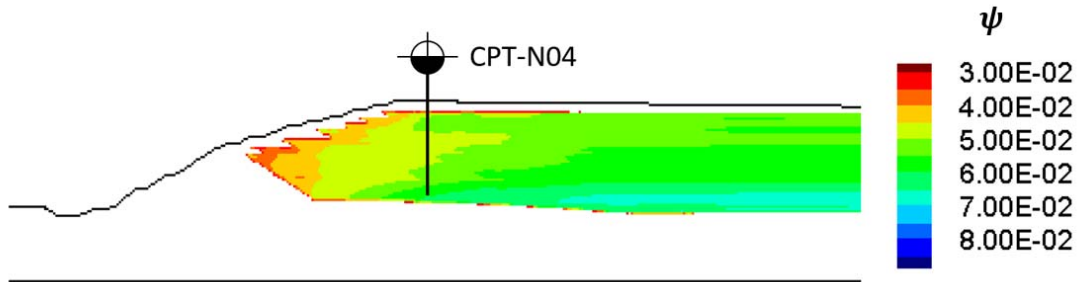
Figure 8-4: Distribution of state parameter in tailings on completion of Stage 10 raise

The tailings state parameter was specified concurrently with each raise, consistent with the CPTu data. Subsequent placement of tailings compressed the underlying tailings. More importantly, the embankment deformations somewhat densified (improved) the tailings through their response to distortional stress (shear induced compaction). Figure 8-4 shows the distribution of the state parameter at the completion of Stage 10, which was the situation at the time of the 2017 CPTu campaign. As shown in this figure, this distribution of state varies considerably from that associated with the CPTu campaign conducted in 2017. This distribution of state arises from the stress history imposed upon the tailings and modelled by NorSand. It is of special interest to observe that the CPTu test program was limited in its ability to determine the variation of state that prevailed in the tailings within the affected region prior to the onset of instability.

The FLAC 3D results for the best-fit model were contoured as values of η_{IL}/M_t on Figure 8-22, with the greatest values being a little in excess of $\eta_{IL}/M_t \sim 0.6$, while the state parameter was contoured on Figure 8-4 with the 'typical' value for the tailings supporting the upstream raise being $\psi \sim 0.05$. Comparison of these estimates with the estimated instability locus on Figure 8-23 indicates the tailings were close to their instability condition after completion of the Stage 1 Buttress.
