Report on NTSF Embankment Failure

Cadia Valley Operations

Independent Technical Review Board

Date: April 17, 2019

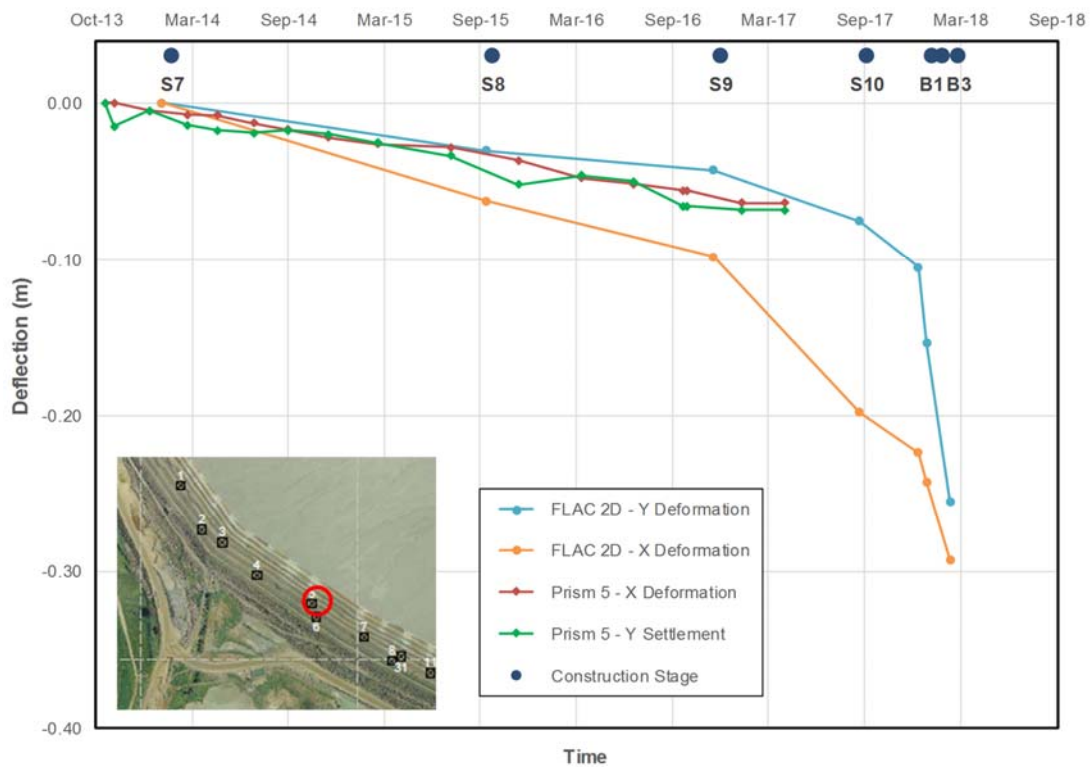
Figure 8-5: Comparison of displacements from 2D best-fit simulations with those measured

Measured displacements at the survey prisms are compared with those of the FLAC model on Figure 8-5. Overall;

- Both FLAC and measured displacement show comparable values on average,
- Within this average trend, FLAC computes less vertical settlement than measured. FLAC is showing predominantly horizontal translation at the Stage 5 crest whereas the data indicate movement at approximately a 45° angle downwards, and
- FLAC displacements accelerate far faster with buttress construction than the InSAR trend indicates.

Overall, this is an acceptable initial match of surface displacement monitoring data allowing preliminary assessment of the underlying processes. Moreover, the calculated surface displacement pattern provides an approximate but rational explanation for the appearance of the cracks that were observed and this is discussed in detail in Appendix H.

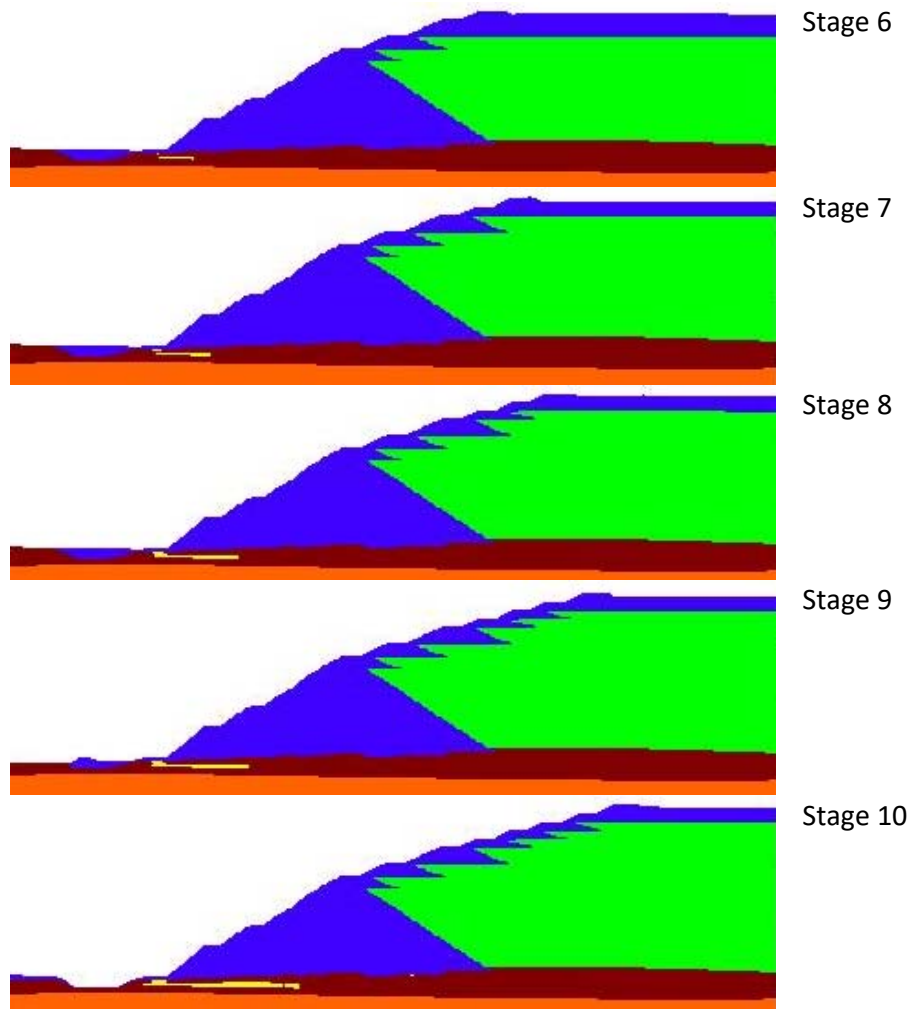
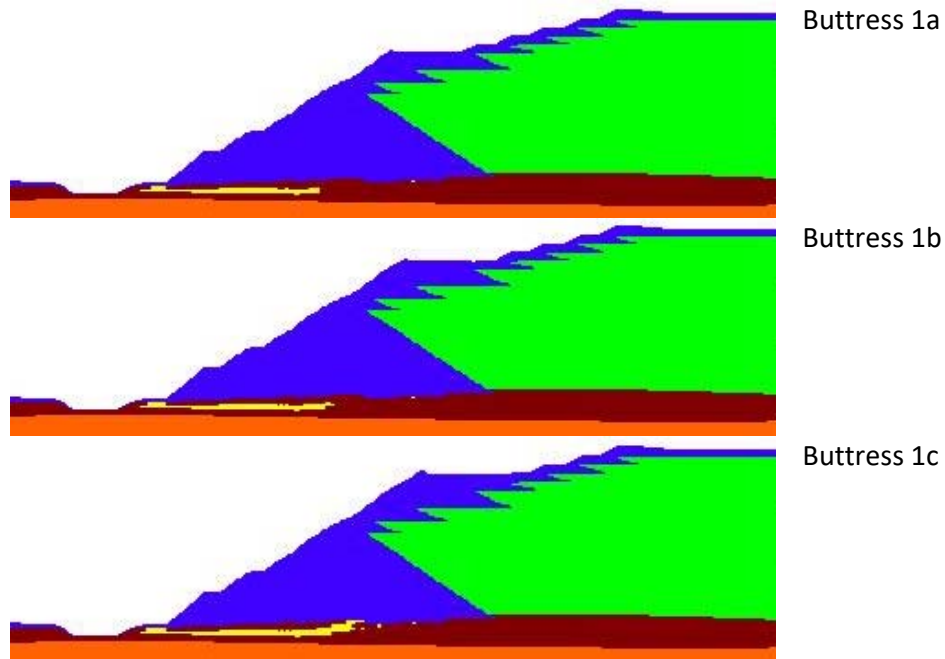
Figure 8-6: Development of strain weakening (shown as yellow zone) in Unit A

An important discovery early in the investigations was the presence of soft and strain-weakening residual soils, discussed in Section 5 and Appendix D. These residual soils have been explicitly modelled, with FRV Unit A constituting the weakest stratum that controls the foundation response. The manner in which strain weakening developed in the best-fit 2D model is illustrated on Figure 8-6.

The zone where the residual soil has been loaded past its peak strength and into the condition of losing strength as displacements develop further (strain weakening) is shown as yellow on Figure 8-6. The first onset of strain weakening began at the toe of the embankment after the Stage 5 raise and developed upstream throughout the subsequent construction stages.

While the strain weakening process that creates large deformation in the foundation is captured in this analysis as seen in Figure 8-6, it initially appears at the toe of the structure and migrates inwards. This is not in accord with the time of the observation of thrusting at the toe prior to the onset of Phase 2 (see Figure 3-16). Nevertheless, the ITRB accepts the associated deformations and internal stresses as adequate for preliminary assessment of mechanisms.

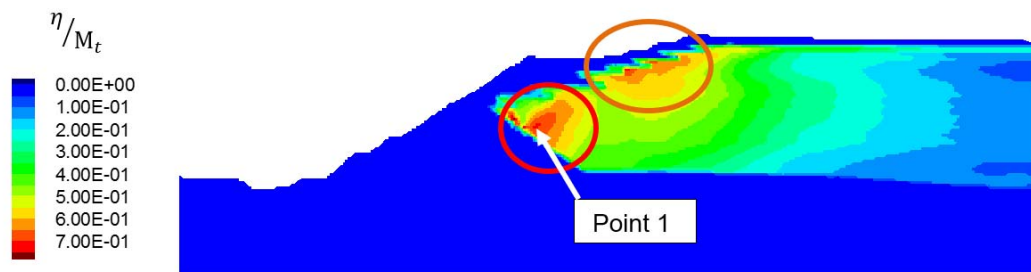
Figure 8-7: Distribution of controlling stress ratio in tailings after berm construction

The foundation movements from strain-weakening propagate upwards into the tailings, and in effect manifest themselves as a loss of support to the tailings. This loss of support then requires the tailings to increasingly mobilise their own strength. That mobilisation is shown in Figure 8-7 at the time that the Stage 1 Buttress had been completed. The figure plots the stress ratio η , which reflects the degree of mobilisation of the strength of the soil. If the soil is in its critical state, a value of unity for this ratio indicates continuous deformations at constant load. If the soil is looser than its critical state, as is the case of the NTSF tailings, the transition to continuous deformation starts at a lower value of this ratio. The important result from the 2D modelling is the determination of the relatively highly stressed zones which are emphasised on Figure 8-7. The loading path associated with these zones has been explored with specific laboratory tests. In this figure, the failure mechanism initiates in the red zone and propagates outwards.

The stresses developed within the tailings were determined from the FLAC 2D analysis and Point 1 is reflective of the highest mobilised strength, as illustrated in Figure 8-7. Details of the stress distribution within the dam are given in Appendix H. The state of specimens adopted reflected the calculated state at Point 1. Both sandy and silty tailings were used in the laboratory program because of somewhat greater tendency for liquefaction in the sandy deposits. The results from the cyclic testing on the specimens are presented in Figure 8-12. It is evident that the imposed cyclic loading has had no significant effect on the specimens. The ITRB concludes

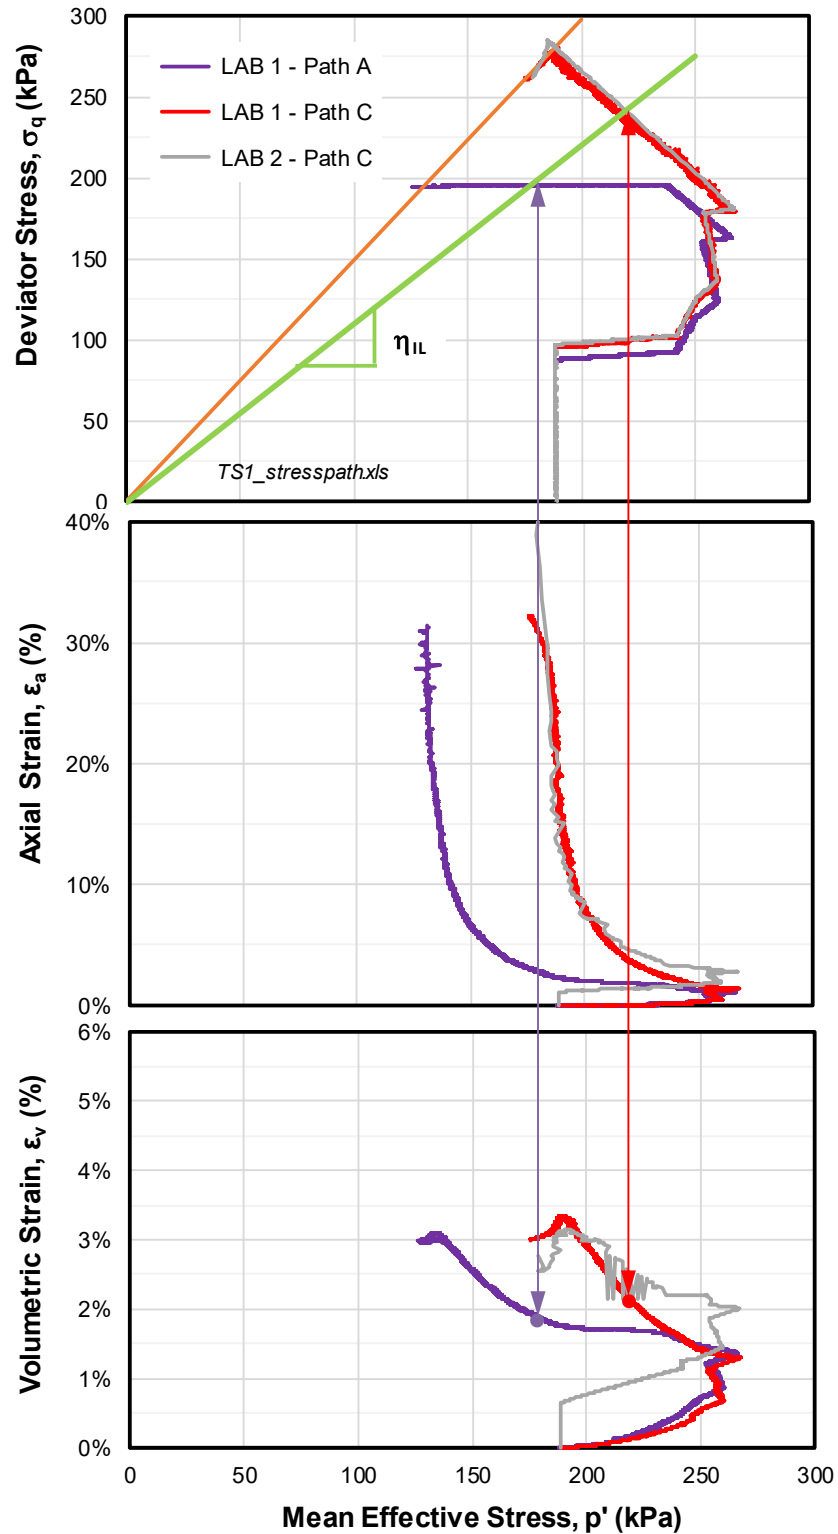
Figure 8-8: Measured soil behaviour at 'Point 1' along computed stress path

Three load controlled triaxial compression tests (stress path tests) were undertaken to investigate the instability locus and these are shown on Figure 8-8. Two of these tests were duplicates, using two independent laboratories to confirm that the data did not contain an unappreciated artefact caused by some particular aspect of the test apparatus. The data is annotated by the path followed and presented in terms of the stress-path followed (top plot), the associated axial strain (middle plot) and the volumetric strain (bottom plot). All these samples were slightly looser than thought to be the case insitu.

Blue vertical arrows have been drawn on Figure 8-8 to indicate how the different aspects of the measured behaviour in each of the three plots link together. The axial strain data, the middle plot of Figure 8-8 is the key indicator of the soil response. These strains are small ($< \sim 2\%$) throughout the loading along the computed stress path, which are consistent with the strains computed in FLAC. When the stress path is extended, whether along A or C direction, strains continue to be small until a sudden acceleration in the strains develops. The acceleration is indicated by the vertical blue arrows. Some judgment is involved here, as it could be argued that the transition strain is either 3% or 4%. Notwithstanding this, the acceleration has developed at less stress than that of the soil's critical state which is shown as the green line in the upper plot. The acceleration point is inferred to be the instability locus (blue line, upper plot) as the much faster increase in strain with small increase in load is a direct consequence of a sudden reduction in plastic hardening.

Path C represents the scenario where there is approximately linear loading vector over the last two lifts of the Stage 1 Buttress, a situation indicated by FLAC.

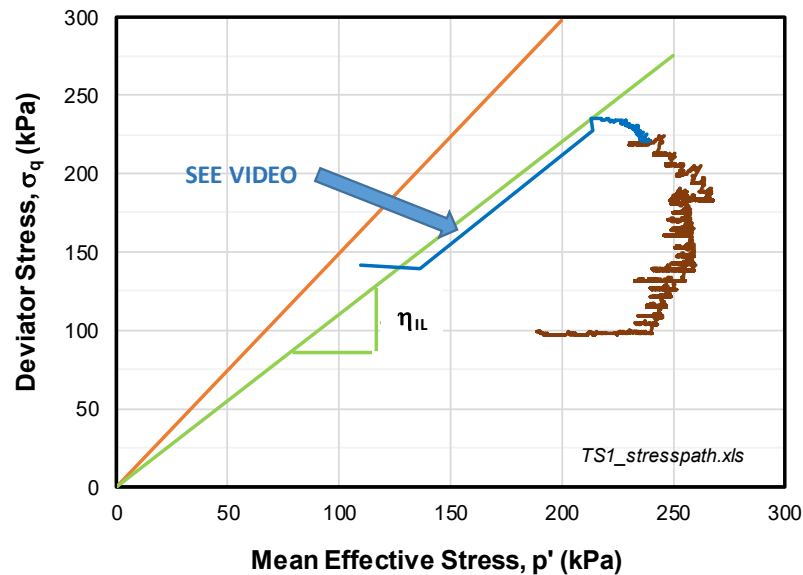
Figure 8-9: Undrained instability following drained loading

Path B is shown on Figure 8-9. This sample was loaded drained (shown in brown) to the end-stress of the FLAC load stress-path before closing the drain line and continuing with the loading (shown in blue). When subject to a small undrained increment of shear stress, the sample collapsed essentially instantaneously (see the video in Appendix E, Annexure ER), at the same instability locus as identified in Path A and Path C loadings.

The ITRB did not enquire into the nature of the 'perturbation'. However, possible explanations could be; a natural acceleration of the foundation movement; excess pore water redistribution within the yielding FRV Unit A or FRV Unit A deformations breaching a strain threshold that caused disaggregation of the structure in that stratum. Rather, the ITRB accepted that the condition of a transition into liquefaction was imminent and then enquired as to how the slump might have transitioned to Phase 2. This was done by switching the tailings from their drained condition to an undrained one; that is, implementing the situation just a little past the stress-strain behaviour shown on Figure 8-9.

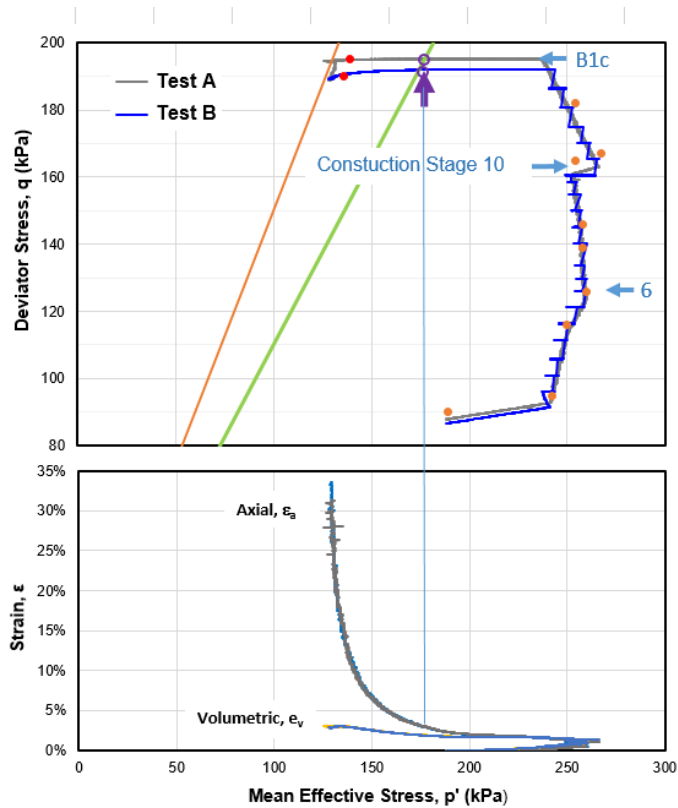
Figure 8-10: Results of laboratory test for Point 1 under rising ground water pressure

Figure 8-10 presents laboratory data that illustrate Mechanism 2. The changes in stress at Point 1 with the various stages to construction are presented to the end of Stage 1 Buttress construction. It is seen, that at this time, the local stresses are far from the instability locus. If one envisaged a local rise of pore pressure generated by a rise of ground water, the stress path would migrate in a horizontal direction as indicated. When it intersects the instability locus, liquefaction results. However, it is seen that prior to this intersection, strains are accelerating. For this mechanism to occur, pore water pressures that have not been embraced in the hydrogeological synthesis around the NTSF (Appendix F), would have to be evident.

The ITRB found no evidence for pore pressures that have been omitted from consideration in Appendix F. The ITRB discussed in some detail whether high pore pressures caused by buttress construction might have prevailed for a while, but this was discounted on the basis of the high local C_h determined by dissipation testing as part of the 2017 CPTu testing campaign. The ITRB concluded that local transient high pore pressures were not present and did not contribute to the onset of Phase 2. Therefore, Mechanism 2 was discounted.

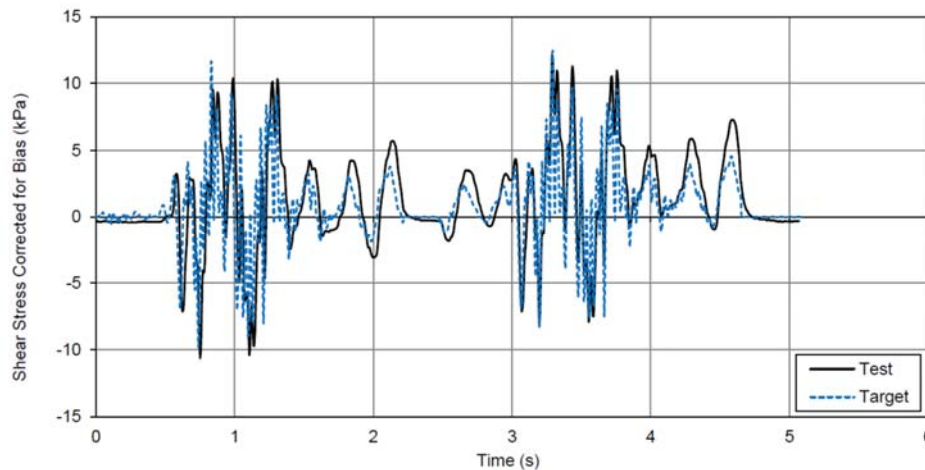
Figure 8-11: Ground motion input to CDSS test simulating earthquake motion at Point 1

Figure 8-11 illustrates the dynamic loading that was utilised in the cyclic testing of the tailings specimens. It differs from routine testing by simulating the actual ground motion computed within the structure. Often uniform cycles are used as opposed to more complex realistic ground motion. Because the test is undrained, and because of test equipment limitations the duration between the two shock was reduced from about ten seconds to one second. The ITRB does not regard this as consequential.

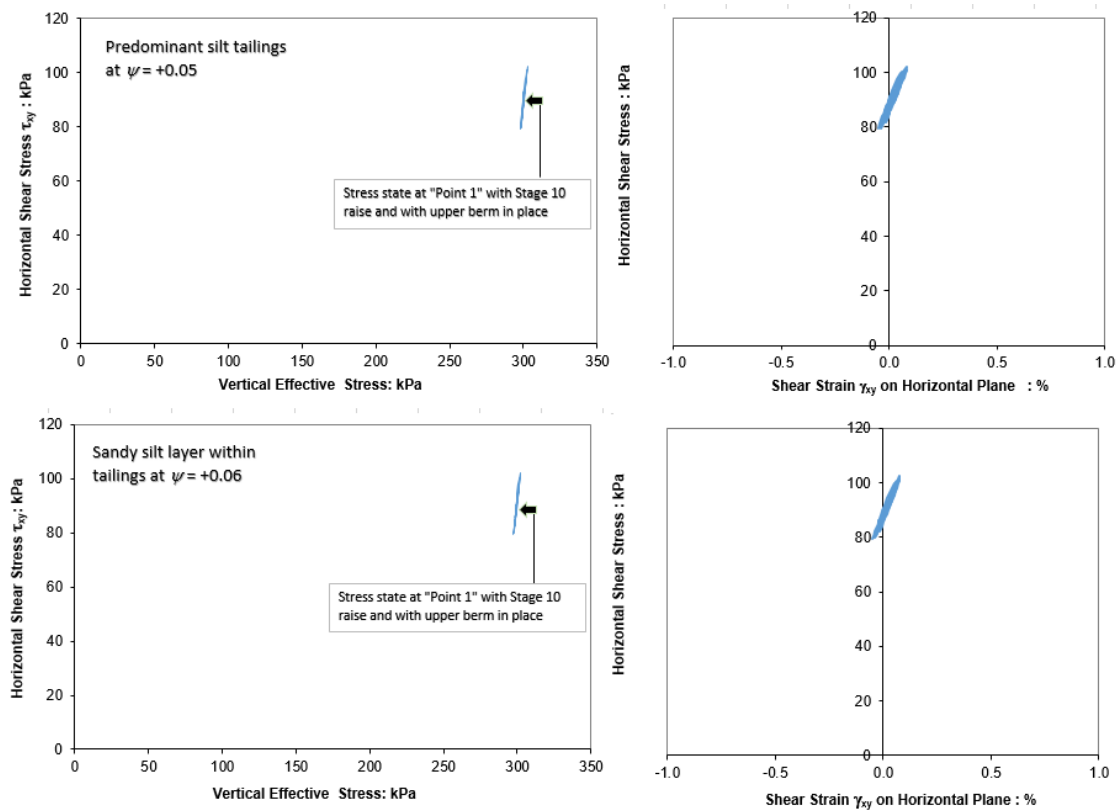
Figure 8-12: Response of Point 1 tailings to 8 Mar 2018 earthquake in cyclic simple shear

that the earthquakes did not contribute to the onset of Phase 2. Therefore, Mechanism 3 can be discounted.

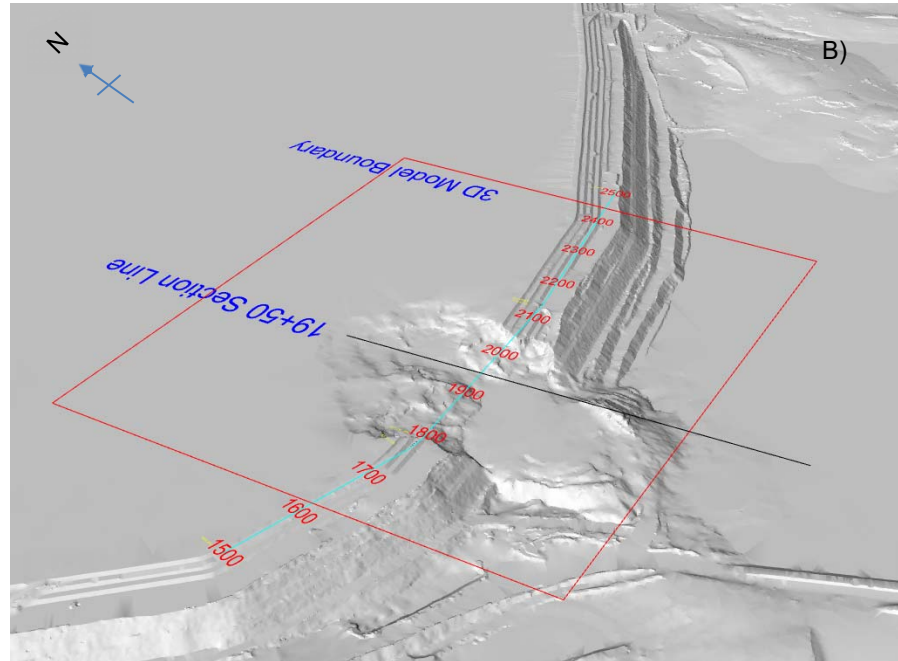
Figure 8-13: Oblique view of slump illustrating extent of 3D model

The location of the 3D model on the embankment is shown in an oblique view on Figure 8-13, the 3D model extends beyond the slump zone sufficiently so that the edges of the model do not influence the situation in the slump. This figure also shows the location of the section used in the 2D analysis just discussed.

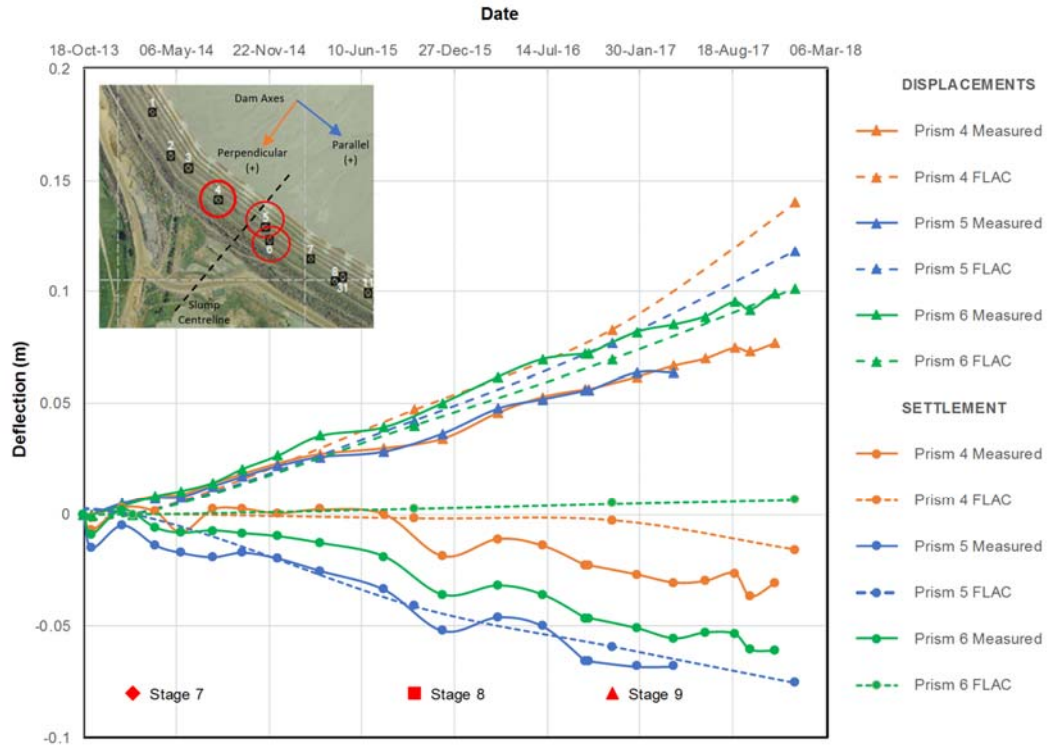
Figure 8-14: FLAC 3D computed and measured prism displacements perpendicular to the dam axis

For Scenario 33, FLAC 3D displacements are compared with measured displacement at survey prisms in Figure 8-15 and InSAR data in Figure 8-15. Overall:

- Both FLAC and measured outward displacement are very similar;
- FLAC develops crest settlement in a similar range to the measured data;

- FLAC displacements increase with buttress construction as indicated by the InSAR trend;
- FLAC computes displacement gradients consistent with crack locations; and
- The limited toe heave in FLAC is reflected in the Nov/17-Feb/18 InSAR trend.

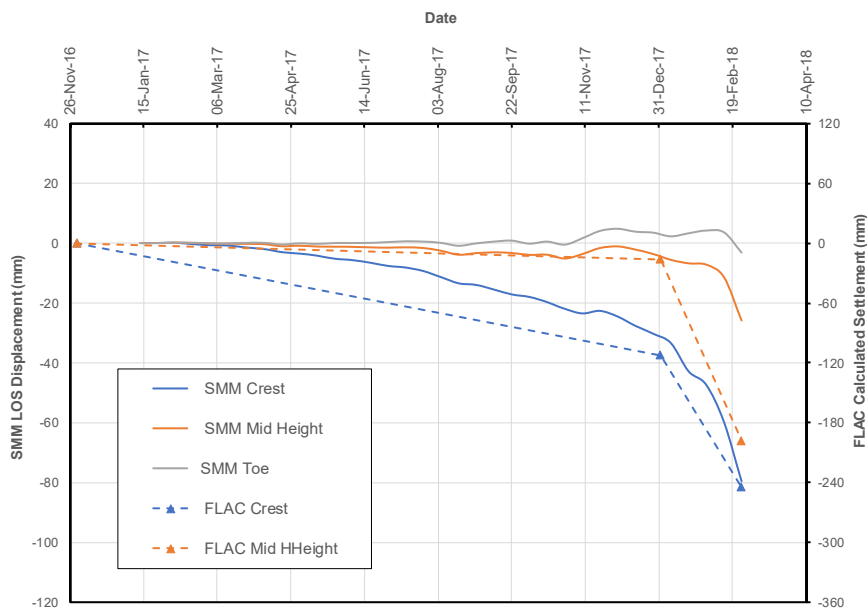
Figure 8-15: FLAC 3D computed and InSAR SMM trends

It should be noted that InSAR SMM presented in Figure 8-15 are in the direction of the satellite LOS and scales have been adjusted to demonstrate the trend rather than absolute values

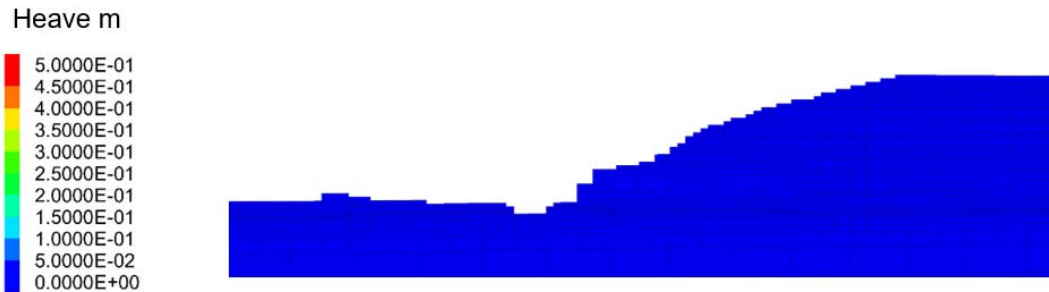
Figure 8-16: Heave computed at end of Stage 10 raise

The heave at the toe of the NTSF was computed using FLAC 3D. Figure 8-16 indicates that the heave at this location was negligible at the end of the Stage 10 raise (before buttress construction). However, Figure 8-17, an isometric view with the toe excavation, indicates a heave of about 0.25 m developing at the edge of the excavation on completion of the Stage 1 Buttress. Although there were no heave measurements at the toe, the results are consistent with the InSAR trend at the toe and witness statements on the day of the Event.

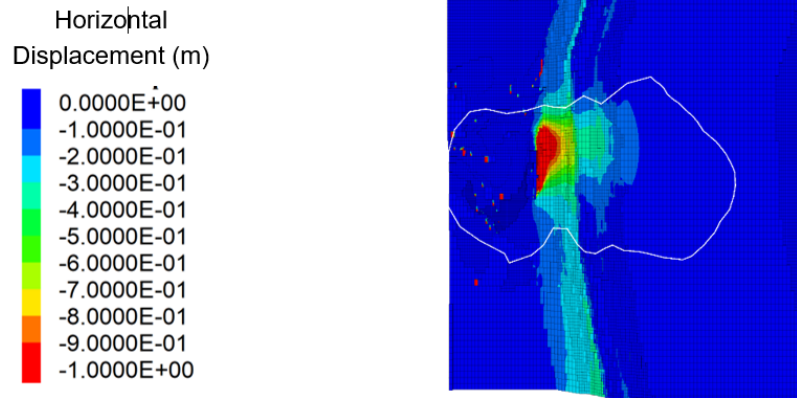
Figure 8-18: Horizontal displacement contours at 8 March 2018

Further insight is gained from horizontal displacement contours at the end of the Stage 1 Buttress construction, shown on Figure 8-18. The computed displacements developed across the width of the slump are similar to those developed during March 9, 2018. The subsequent development of the flowslide (Phase 2) is not captured in the analysis shown here and thus the simulation neither 'runs-out' at the toe nor regresses at the crest.

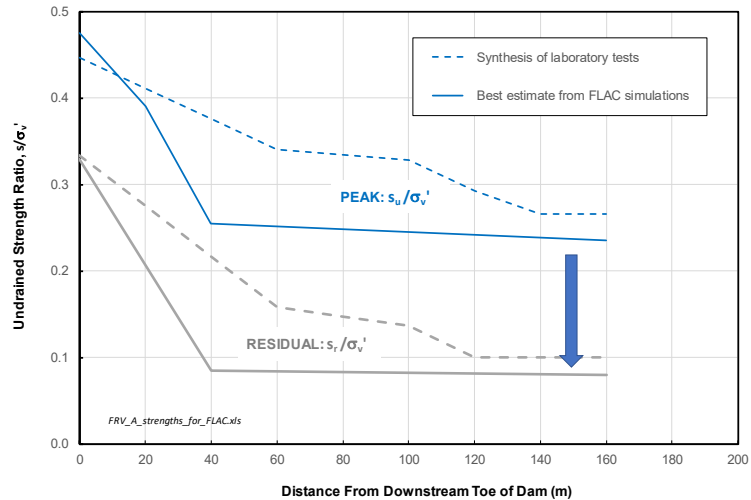
Figure 8-19: FRV Unit A strengths used in best-fit FLAC 3D simulation

The optimised FRV Unit A strength from the FLAC modelling, expressed as the available undrained strength as the foundation transitions from a drained situation during the embankment raising into incipient undrained strength loss as the slump developed, is shown on Figure 8-19 plotted against distance upstream from the toe of the dam. Also shown on this figure is the inferred operating strengths synthesised from the laboratory testing as summarised on Figure 5-8.

The strengths shown in blue on Figure 8-19 comprise a peak strength, up to which the FRV Unit A shows drained behaviour, followed by a transition into an undrained strength loss. This loss in undrained strength is a result of pore pressures increase due to foundation movement, not a response to embankment vertical stress. This transition was referred to earlier as 'strain weakening' and its effect on the operating strength is indicated by the downward arrow on Figure 8-19.

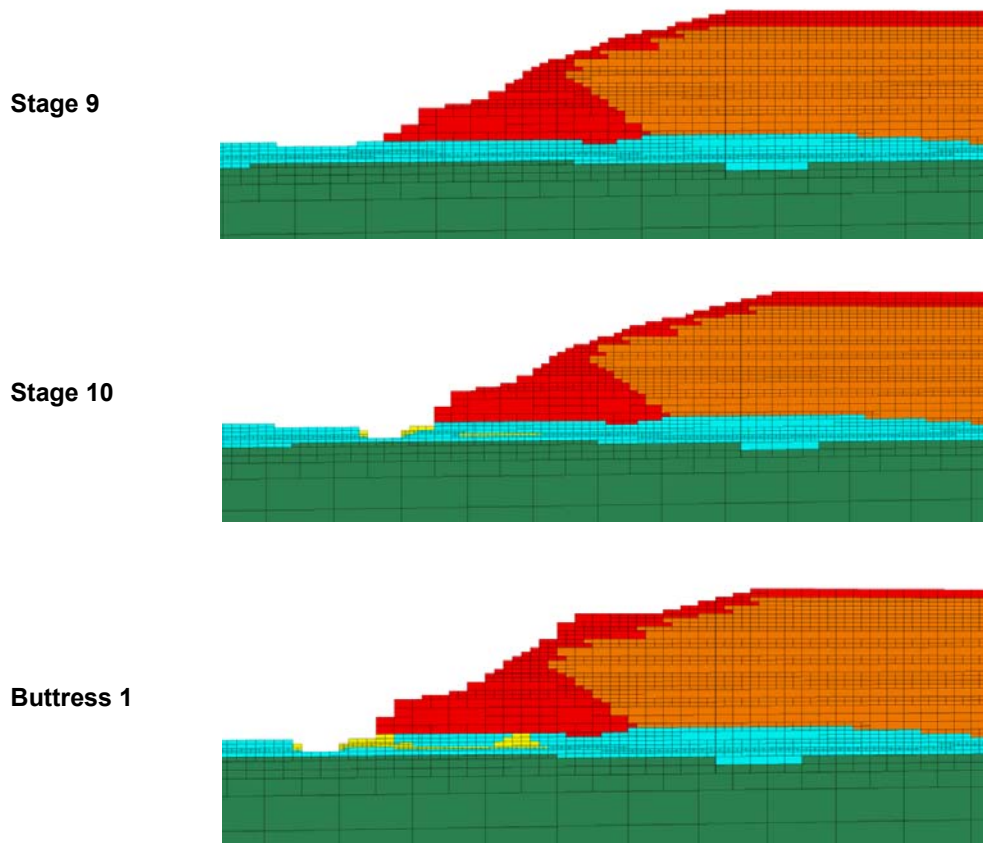
Figure 8-20: Development of strain weakening in best-fit FLAC 3D simulation

Strain-weakening was a central aspect of the FLAC 2D model and it continued to be important in FLAC 3D. The zone where the FRV Unit A has been loaded past its peak strength and into the condition of strain weakening is shown as yellow on Figure 8-20. The first onset of strain weakening began at the toe of the embankment after the Stage 9 raise, and developed upstream throughout the following construction stages. It should be noted that this strain weakening is also accounted for by a significant reduction in available frictional resistance as it converges on the frictional residual strength (see Appendix D).

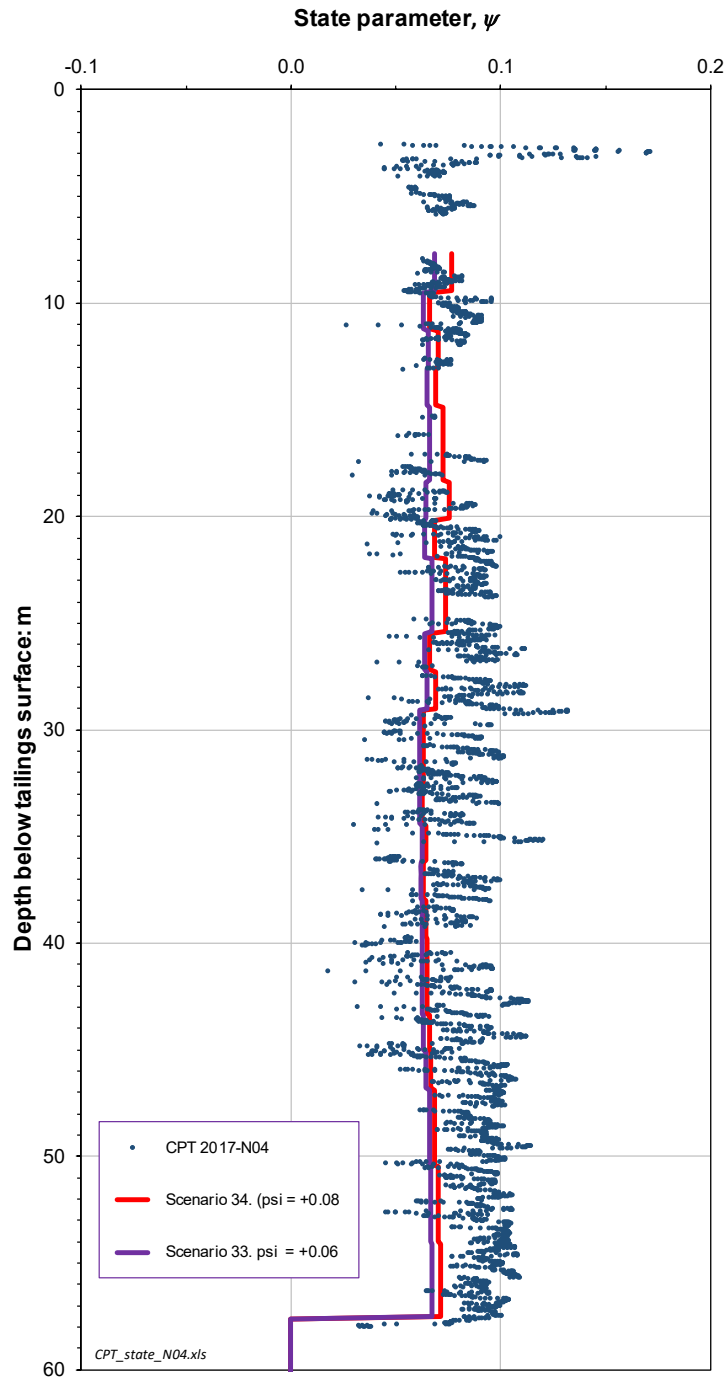
Figure 8-21: State parameter profile at N04 location on completion of Stage 10 Raise

The calculated state parameter profile, on completion of the Stage 10 raise, and used in Scenarios 33 and 34, is compared with that assessed from CPT-N04 data on Figure 8-21. As can be seen, the state parameter profile used the FLAC 3D simulation was slightly denser than that inferred from the CPTu data.

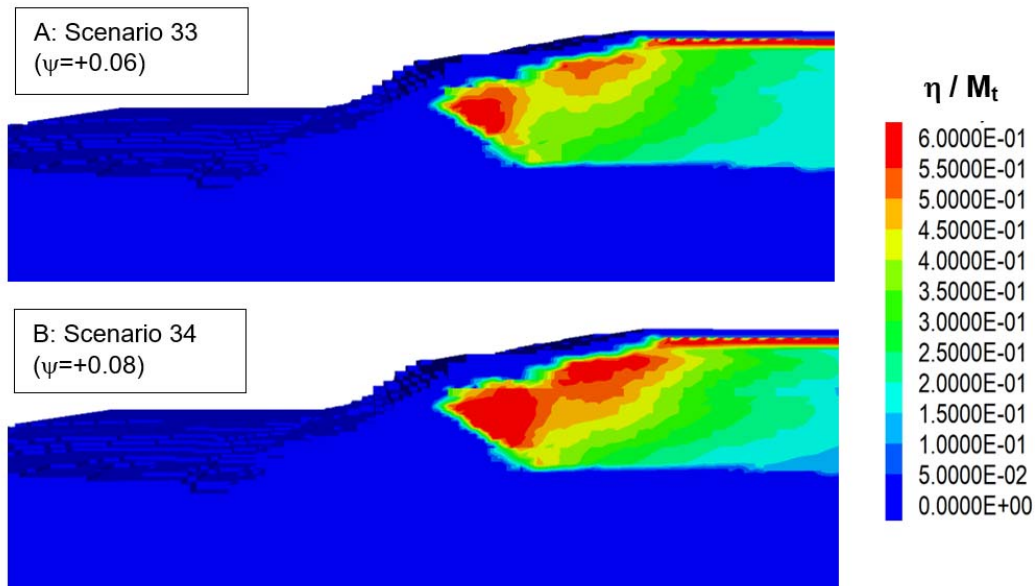
Figure 8-22: Influence of state parameter on extent of mobilised tailings strength

The FLAC 3D simulations were very sensitive to the initial state parameter in the tailings, with the slightly denser scenario appearing a closer match to that which was observed. This is illustrated in Figure 8-22 which shows the contoured mobilised stress ratio (η/M_t) of the tailings, with red approaching the instability limit and a transition to liquefaction. Figure 8-22 a) is for the simulation that was stable with the buttress in place (Scenario 33) while Figure 8-22 b) is for Scenario 34 which failed to converge.

The FLAC 3D results for the best-fit model were contoured as values of η_{IL}/M_t on Figure 8-22, with the greatest values being a little in excess of $\eta_{IL}/M_t \sim 0.6$, while the state parameter was contoured on Figure 8-4 with the 'typical' value for the tailings supporting the upstream raise being $\psi \sim 0.05$. Comparison of these estimates with the estimated instability locus on Figure 8-23 indicates the tailings were close to their instability condition after completion of the Stage 1 Buttress.

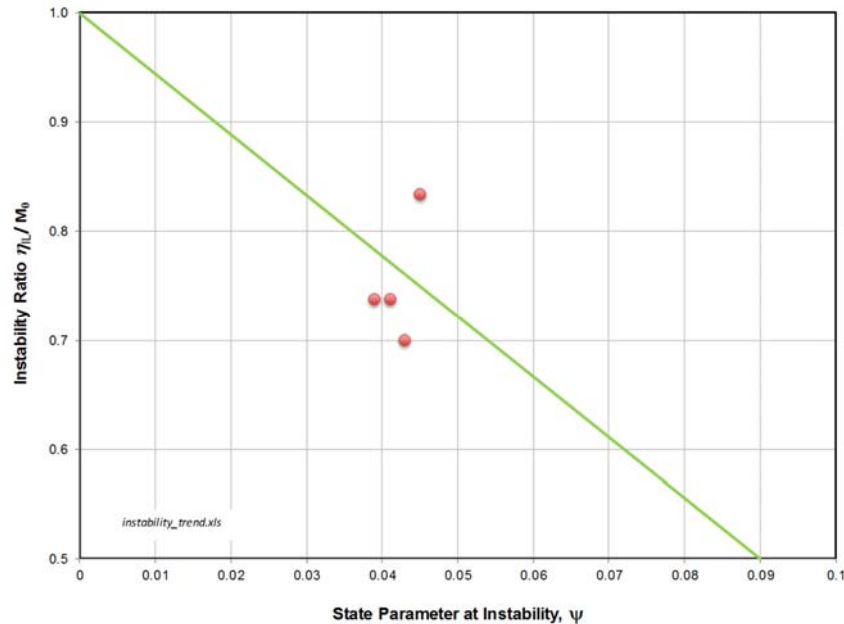
Figure 8-23: Instability locus for NTSF tailings

As noted previously, tests to investigate the instability locus were a little denser than indicated by the CPTu testing. Notwithstanding this, the instability locus must intersect the CSL at $\psi = 0$ and is also known to be linear with ψ . The instability limit inferred from the various stress path tests (red dots) are shown on Figure 8-23, together with a best-estimate trend for the NTSF tailings instability locus.

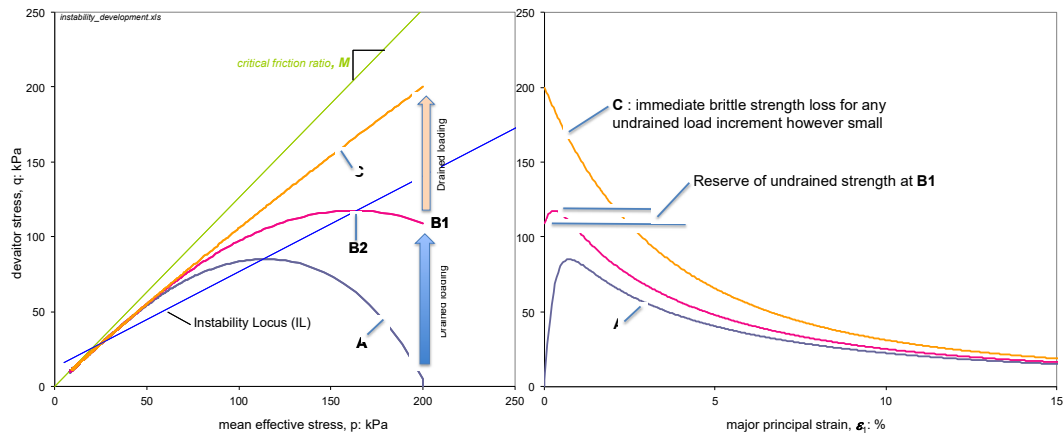
Figure 8-24: Undrained instability of loose soil during drained loading

The deformation analyses, particularly the FLAC 3D best-fit 3D analysis, established that the tailings were approaching (or at) their instability limit after completion of the Stage 1 Buttress. The situation was drained at this time. The nature of the instability limit is illustrated on Figure 8-24 which was computed using Norsand and typical tailings properties (Been, 2016) When soil is stressed to its instability limit, a little above the loading shown as 'B' on Figure 8-24, any 'rapid perturbation' will result in a sharp reduction in the undrained strength as can be seen from this curve 'C'. Therefore, it can be concluded that the NTSF embankment was in a very precarious state at 12:00hrs March 9, 2018.

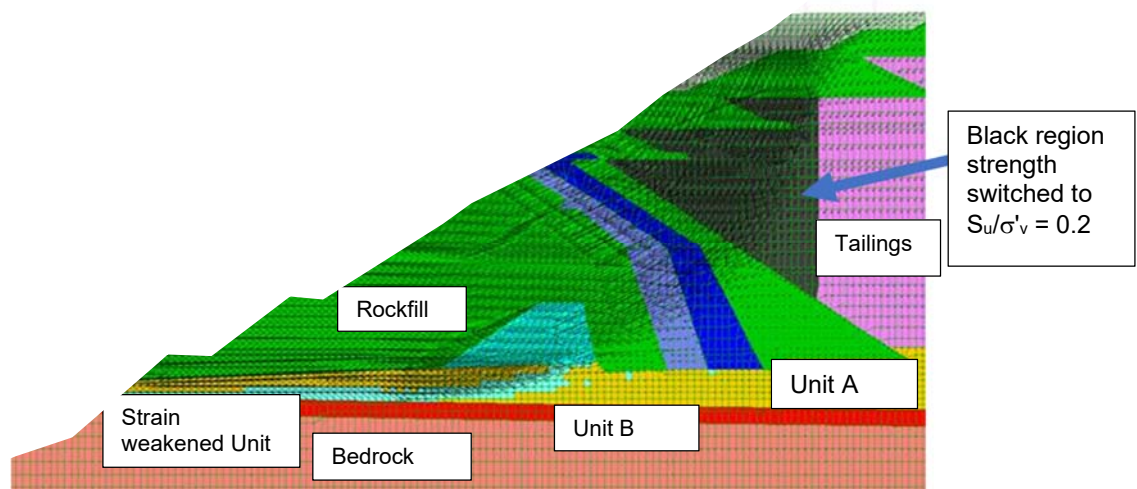
Figure 8-25: Displacement vectors following change from drained to undrained loading

The effect of liquefaction was simulated using the FLAC 2D model. Liquefaction was simulated by assigning an undrained strength ratio to $S_u/\sigma'_v \sim 0.20$ to the region of tailings adjacent to the Stage 1 rockfill that was identified in the Phase 1 analyses as being close to its instability locus, as illustrated on Figure 8-25. The resulting displacement vectors for the imposed strength change are shown on this figure and provide a visual representation of the failure mechanism.

A distinct concentration of displacements is apparent in the region of undrained strength mobilisation. This zone of concentrated displacements originates at the upstream side of the Stage 1 Buttress and passes through the tailings and into the strain-weakened zone of the foundation. This distinct break in displacement pattern would lead to cracking of the dam surface at roughly the location where it was observed in the field.

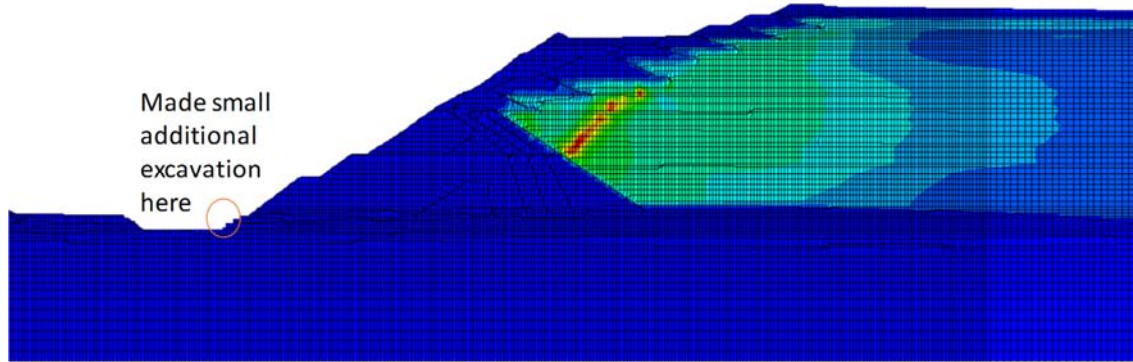
Figure 8-26: Contours of mobilised stress ratio η_u/M_t after a small undrained perturbation

Contours of the stress ratio η_{II}/M_t are shown on Figure 8-26. Although this model did not reach numerical convergence, (indicating that the model could not determine a stable solution during this analysis), the partial results that were obtained showed that the region of tailings immediately upstream of the Stage 1 embankment would generate a very high stress ratio. Essentially, the zone of tailings shown in orange/red on Figure 8-26 had already transitioned to their critical state or residual strength. This is the expected behaviour referred to earlier where very little strain is needed to go from peak undrained strength to residual strength.

Most interestingly, if Figure 8-26 is compared to the post-slump survey shown on Figure 2-2 there appears a remarkable resemblance in terms of the loss of most of the original downstream-constructed dam during the Event.

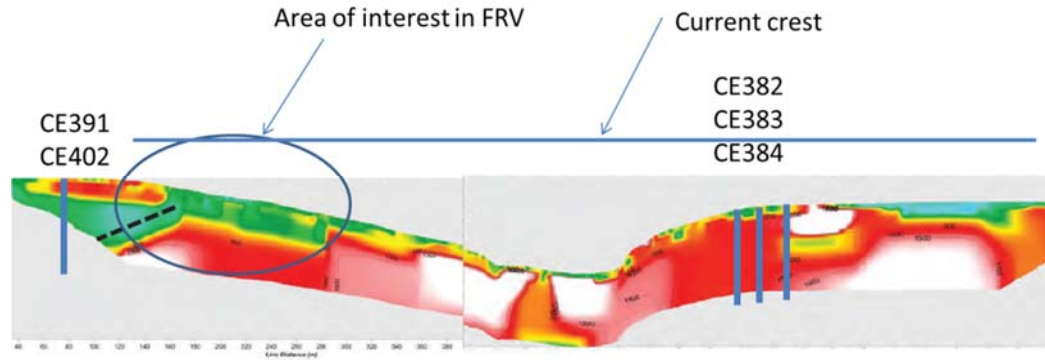
Figure 9-1: Longitudinal section along the STSF showing ERI and drillholes

In the view of the ITRB, coverage and resolution of the drilling and laboratory testing may not have been adequate to confirm that anomalous weakness in all geological units will have been identified. An illustration of such a gap in coverage is located between drillholes CE402 and CE383 as shown in Figure 9-1. The following additional investigations are therefore advocated:

- Drilling to characterise the zone(s) of concern.
- Laboratory testing to examine the brittleness and large strain strength of the materials sampled.
- Integration of all results into a site wide geotechnical/geological model that should be calibrated whenever new exposures arise.
- The additional investigation can also be coupled with the installation of the additional instrumentation that is required.

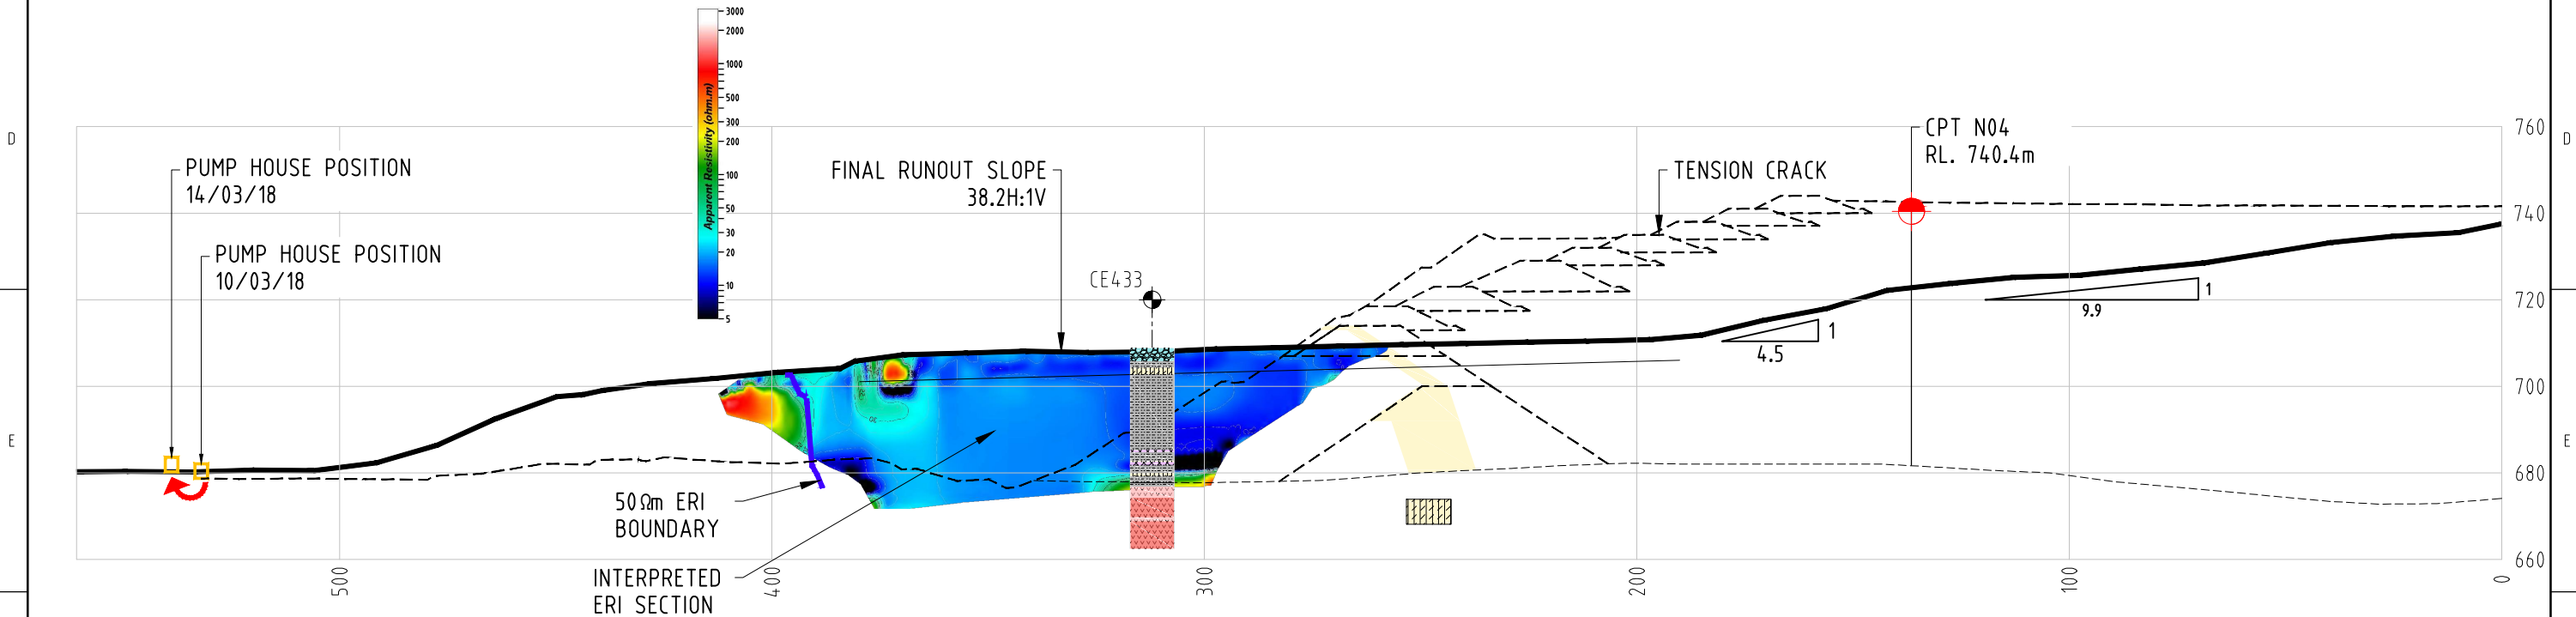
ANNOTATED SECTION THROUGH SLUMP - MARCH 14, 2018
